**NUMBER:** 08-029-05

Flash: Intermittent 4WD Lamp Or DTC P0573 - Brake Switch #1 Circuit High

This bulletin involves selectively erasing and reprogramming the Powertrain Control Module (PCM) with new software.

2005	(KJ)	Liberty/Cherokee (All Markets)
2005	(TJ)	Wrangler

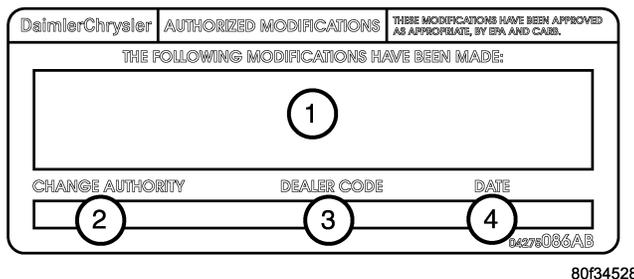
**Fig. 1 AUTHORIZED MODIFICATION LABEL**

- 1 - POWERTRAIN CONTROL MODULE P/N (INSERT P/N) USED
- 2 - CHANGE AUTHORITY: TSB XX-XXX-XX
- 3 - DEALER CODE: XXXXX
- 4 - DATE: XX-XX-XX

14. Type the necessary information on the "Authorized Modification Label" p/n 04275086AB and attach near the VECI label ([Fig. 1](#)).

13. Type the necessary information on the "Authorized Modification Label" p/n 04275086AB and attach near the VECI label (Fig. 1).
