NUMBER: 08-039-15

Tire Pressure Monitoring System May Display Wrong Tire Location

2013 - 2014

Dodge Dart Aero

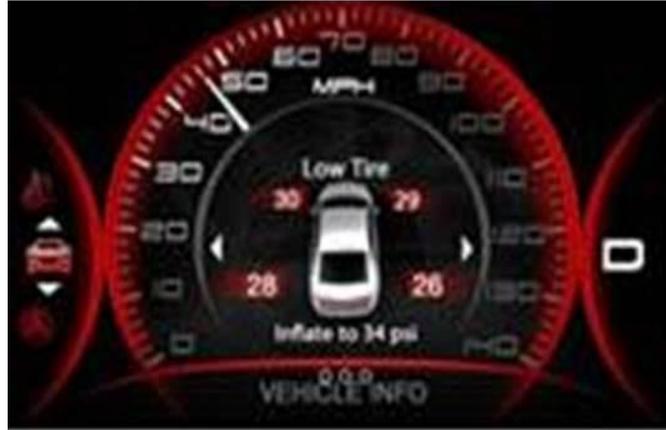
The customer may notice a message “Low Tire” displayed on the cluster:

- Tire Pressure Monitoring screen on the instrument cluster may indicate the incorrect tire location shown when low tire pressure is detected.
- Example scenario: Right rear tire (RR) may show as low on the instrument cluster when actually it may be left front tire (LF) as being low when a tire gauge is used to check tire pressure.

Fig. 1 Low Tire Display On Instrument Cluster

1. Using wiTECH, reconfigure the Body Control Module (BCM). This routine is available under the 'Diagnostic Procedures' tab found on the home, 'Vehicle View', page of wiTECH.
2. From the “Vehicle View” screen, select the “Vehicle Preparations” tab.
3. Highlight the “Restore BCM Proxi Configuration” row and select the green arrow.
4. Follow the wiTECH screen prompts.
5. Perform the “Proxi Configuration Alignment” procedure.
6. Follow the wiTECH screen prompts.
7. Return to the “Vehicle View” screen.
