NUMBER: 08-042-15

DATE: April 28, 2015

Power Wagon Splash Screen Missing In The Electronic Vehicle Information Center (EVIC)

2015 (DJ) Ram 2500 Pickup (Power Wagon)

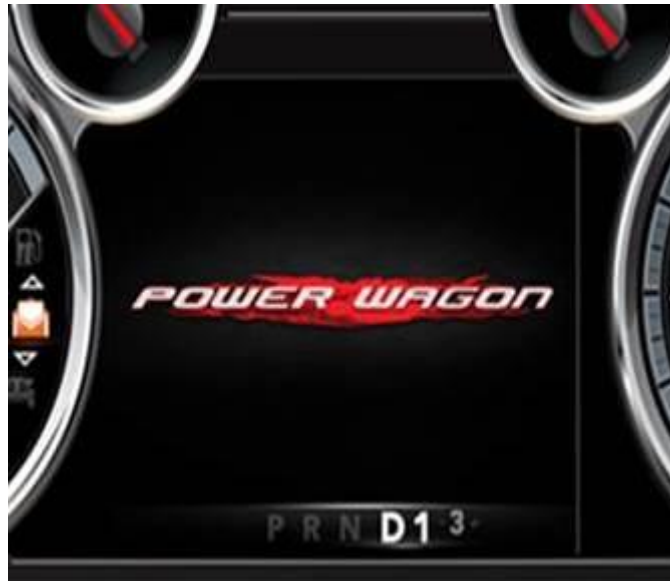
Fig. 1 Power Wagon Splash Screen

The customer may notice the Power Wagon splash screen is missing in the Electronic Vehicle Information Center (EVIC) when the vehicle is first started.

1. Using wiTECH, reconfigure the vehicle. This routine is available under the 'Diagnostic Procedures' tab found on the home, 'Vehicle View', page of wiTECH.

2. Using wiTECH clear any DTCs which may have been set during the reconfiguration.
