NUMBER: 08-052-15

GROUP: Electrical

Compass Direction Displayed Is 90 Degrees Off

2015 (BU) Jeep Renegade

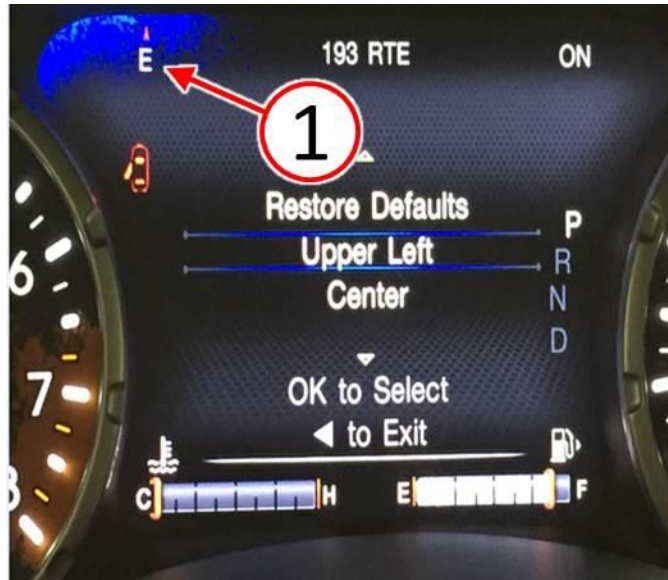
Fig. 1 Compass

The customer may notice the compass direction displayed is 90 degrees off (Fig. 1).

1 - Compass Direction Indicator

1. Using wiTECH, restore configuration and align proxi. This routine is available under the 'Diagnostic Procedures' tab found on the home, 'Vehicle View', page of wiTECH.
2. Using wiTECH clear any DTCs which may have been set during the reconfiguration and proxi alignment.
