**NUMBER:** 08-059-15 REV. B

RA4 Radio Enhancements

This bulletin involves upgrading the software on the RA4 Radio.

2016            (FB)                            Fiat 500X

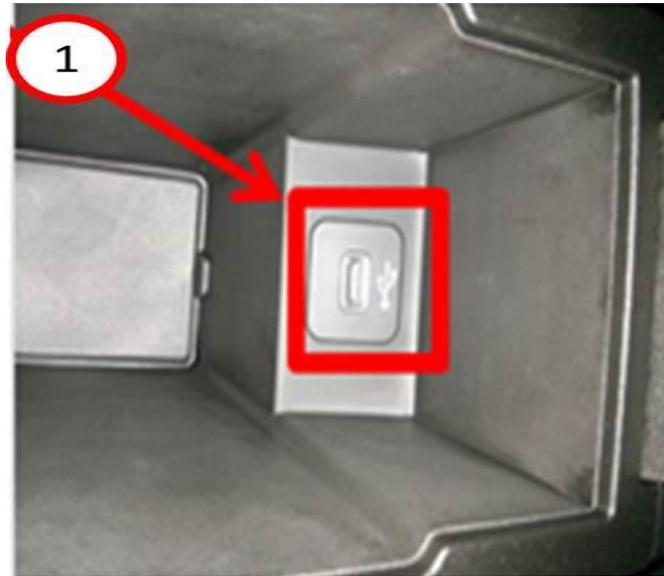
**Fig. 1 Location Of USB Port**

1 - USB port in center console compartment.

7. Remove any customer USB flash drive from both USB ports.
8. With the engine running and radio powered on, insert the **correct** USB flash drive into USB port in the **center armrest compartment**, see ([Fig. 1](#)).
