NUMBER: 08-070-15

Fuel Economy Information Is Missing

2015 (DS) Ram 1500 Pickup

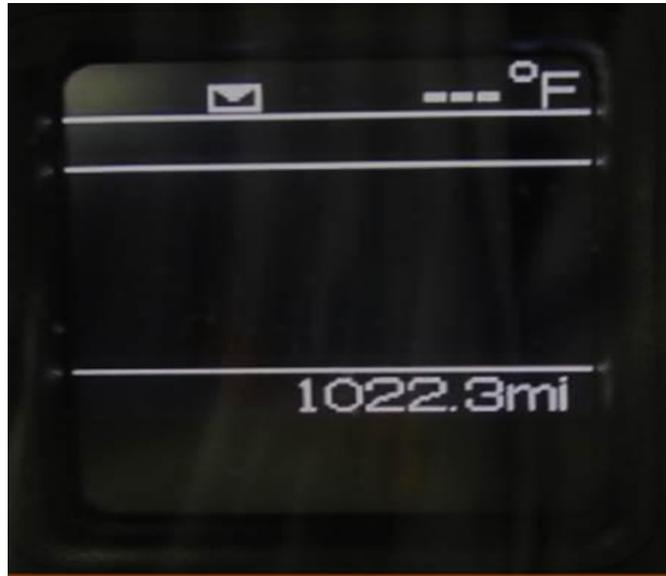
The customer may notice that the fuel economy information screen is blank, as seen in (Fig. 1).

Fig. 1 Fuel Economy Information Missing

Blank cluster display screen

1. Is the fuel economy information missing in the cluster as seen in (Fig. 1)?
 - a. Yes >>> Proceed to [Step #2](#).
 - b. No >>> This bulletin has been complete use LOP 18-19-47-B9 to close the active RRT.
2. Connect the wiTECH and go into the Misc-Function under Instrument Panel Cluster (IPC) tab.
3. Perform the Misc-Function named IPC_42_Initialize_Without_Odometer_Affect, to reset the cluster.

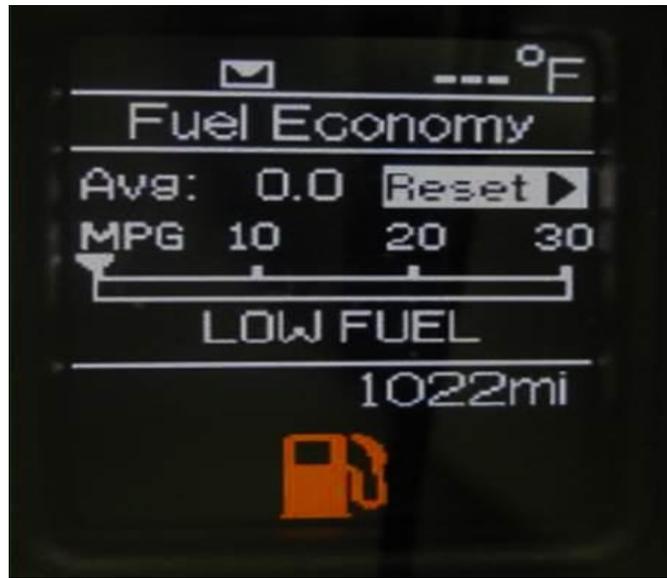
Fig. 2 Fuel Economy Information Displayed

4. Clear any DTCs that may have been set performing this routine.
