NUMBER: 08-071-17

GROUP: 08 - Electrical

RA3 RA4 Radio Enhancements

This bulletin involves inspecting and updating the radio software, if required.

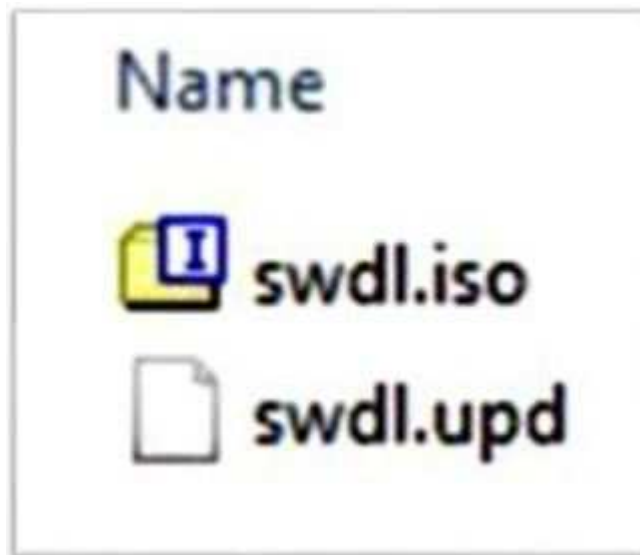
Fig. 1

Two USB Files.

Two files will be loaded onto the USB flash drive (Fig. 1) .

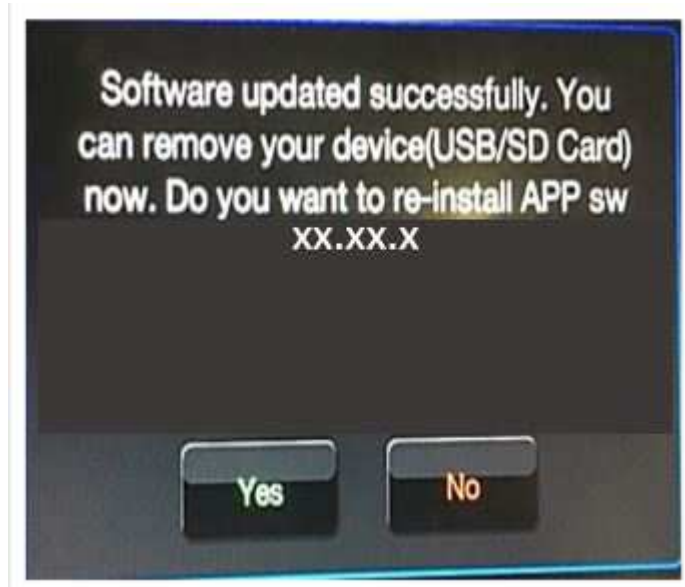
Fig. 5

****Software Updated Successfully****

10. After the update is done, the screen will display the software levels again, see (Fig. 5) .
