NUMBER: 08-096-15 REV. A

Splash Screen Displays Incorrect Logo In The Electronic Vehicle Information Center (EVIC)

2016 (DS) Ram 1500 Pickup

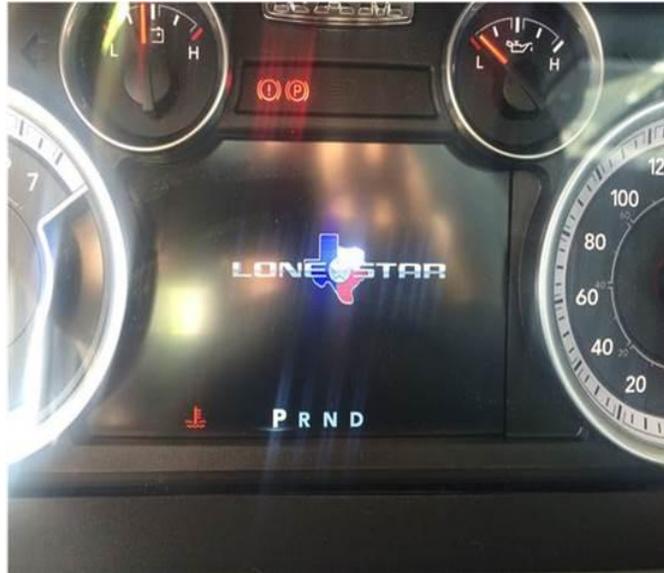
The customer may notice the splash screen is incorrectly displaying a Lonestar logo (Fig. 1) in the Electronic Vehicle Information Center (EVIC) when the vehicle is first started and it should be displaying the Big Horn logo (Fig. 2).

Fig. 1 Lone Star Splash Screen

1. Using wiTECH, reconfigure the vehicle. This routine is available under the 'Diagnostic Procedures' tab found on the home, 'Vehicle View', page of wiTECH.

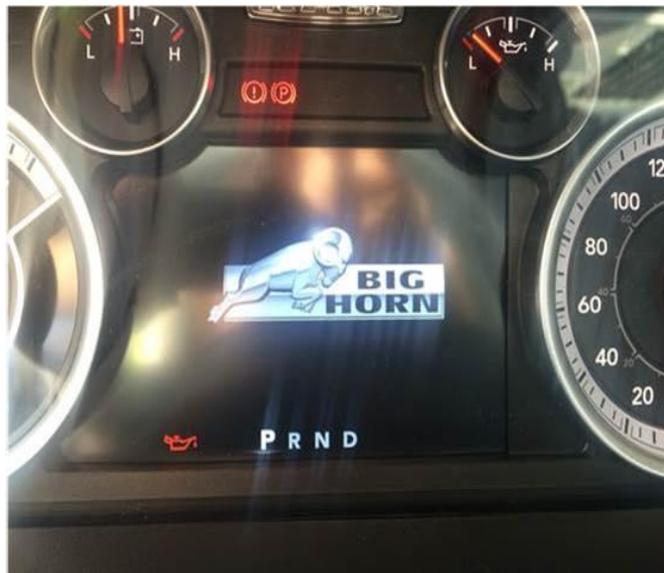
Fig. 2 Big Horn Splash Screen
