# HYUNDAI Technical Service Bulletin

Group	FUEL
Number	08-FL-005
Date	MARCH, 2008
Model	2007-2008 ELANTRA

## RATTLE NOISE FROM ACCELERATOR CABLE

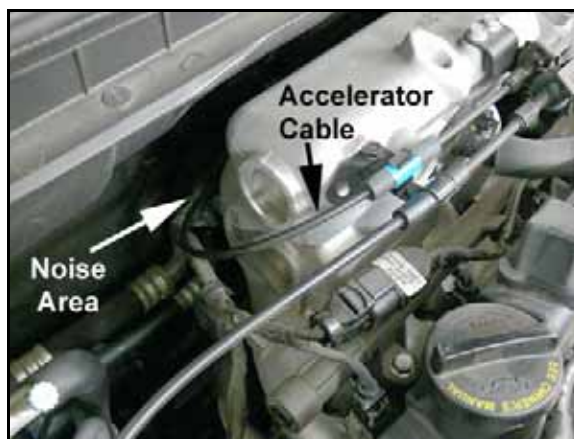
Some Elantra vehicles may have a rattle/buzz/tapping noise from the accelerator cable. This noise is usually described as a body noise heard near the base of the windshield.
