NUMBER: 09-002-04

GROUP: Engine

DATE: January 27, 2004

Short Duration Cold Engine Start-up Ticking Like Sound

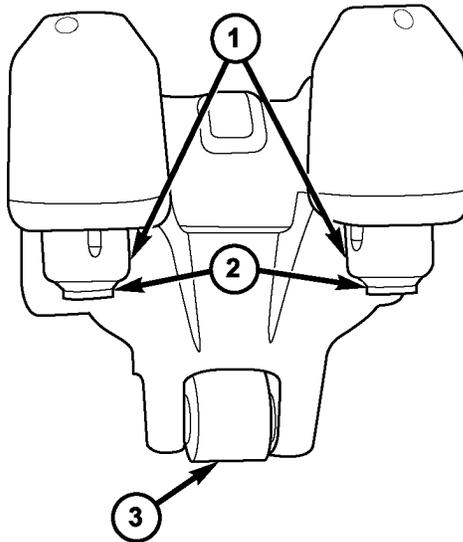
Fig. 1 ROCKER ARM ASSEMBLY

NOTE: If this procedure has already been performed on this vehicle the swivel pad retainers will be colored blue and the swivel pads will be copper in color on the exhaust rocker arm assembly (Fig. 1).

CAUTION: This bulletin only applies to the exhaust rocker arms. Do not install these new parts in the intake as damage may occur.

4. Remove the retainers and swivel pads from each exhaust rocker arm (Fig. 1).

5. Install the new swivel pads and swivel pad retainers on all exhaust rocker arms (Fig. 1).

NOTE: Do not reuse original yellow retainers.

NOTE: Replace all exhaust swivel pads and retainers as a set.
