NUMBER: 09-005-04

Growling Sound On Accelleration

2003 (DR) Ram Truck

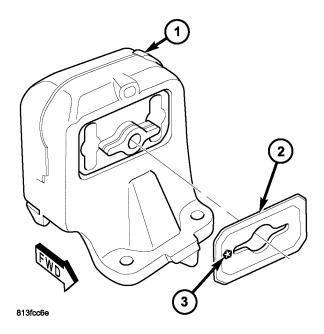
Fig. 1 ENGINE MOUNT

A growling or moaning sound may be present on heavy acceleration when carrying heavy loads or towing. This condition may be cause by the right motor mount contacting the motor mount frame bracket.

Inspect the right engine mount and bracket. If the motor mount is contacting the bracket, witness marks (shiny metal) will be present on the frame bracket. If the witness marks are present perform the Repair Procedure.

- 1. Raise the vehicle on a hoist.
- 2. Place an adjustable jack stand under the engine to support the engine when the motor mount through bolts removed.
- 3. Loosen both motor mount through bolts. Leave the nut on the left side mount as this bolt will not be removed. Remove the nut on the right side.
- 4. Raise the engine with the jack stand until the right side through bolt becomes free. remove the right side bolt. Raise the engine far enough to clear the frame bracket and allow the isolator pad, p/n 55366020AA to be inserted. Insert the isolator on the mount with the Pentastar logo facing the front of the vehicle. (Fig. 1). Lower the bracket and align the mount with the frame bracket and push the bolt through the isolator and bracket with the threads at the rear.

- 1 Right Motor Mount
- 2 Isolator
- 3 Logo Facing Front
- 5. Install the nut and tighten both through bolts to 115 Nm (85 ft. lbs.).
- 6. Remove the jack stand.
- 7. Lower the vehicle
