SERVICE BULLETIN

APPLICABILITY: 2015MY WRX Models with 2.0L DIT Engine
 2015MY Legacy and Outback 2.5L

NUMBER: 09-59-14R

SUBJECT: Rust Treatment Procedure for Heat Shield Retaining Bolt Heads

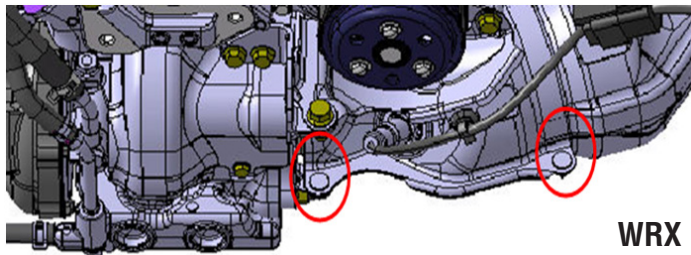
WRX

This bulletin provides a treatment procedure to address a customer concern of rust developing on the front exhaust pipe heat shield retaining bolt heads as shown in the illustrations below.
