**SERVICE BULLETIN**

**APPLICABILITY:** 2015 Legacy and Outback Models

**NUMBER:** 10-81-14R

**SUBJECT:** “Whistling” Sound from Center Console Arm Rest Vents

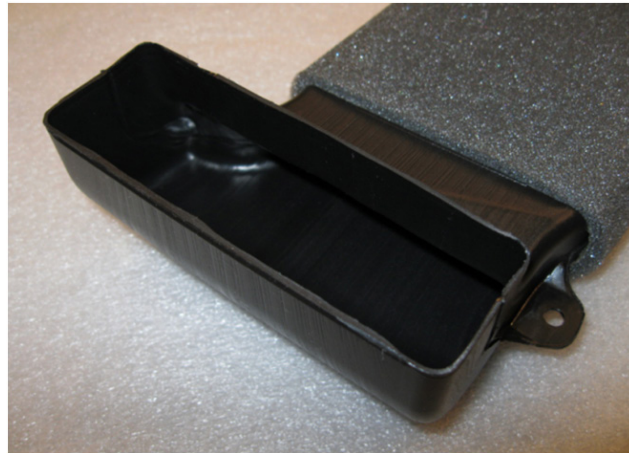
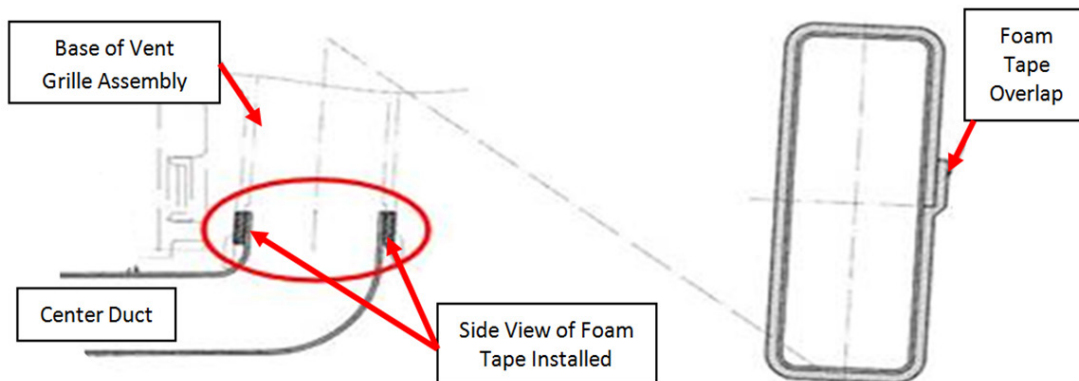
This bulletin provides a service procedure to address customer concerns of a “whistling” sound coming from the rear seat air distribution vents located at the rear of the center console. The sound may be heard when the blower speed is set to high. This condition is repaired with the installation of an additional piece of self-adhesive foam tape which will enhance sealing between the vent grille assembly and center air duct.

- Identify the area of the center duct which fits inside the base of the vent grille assembly as shown in the photo and illustration below.
