FORD:

2010-2012 Transit Connect

ISSUE

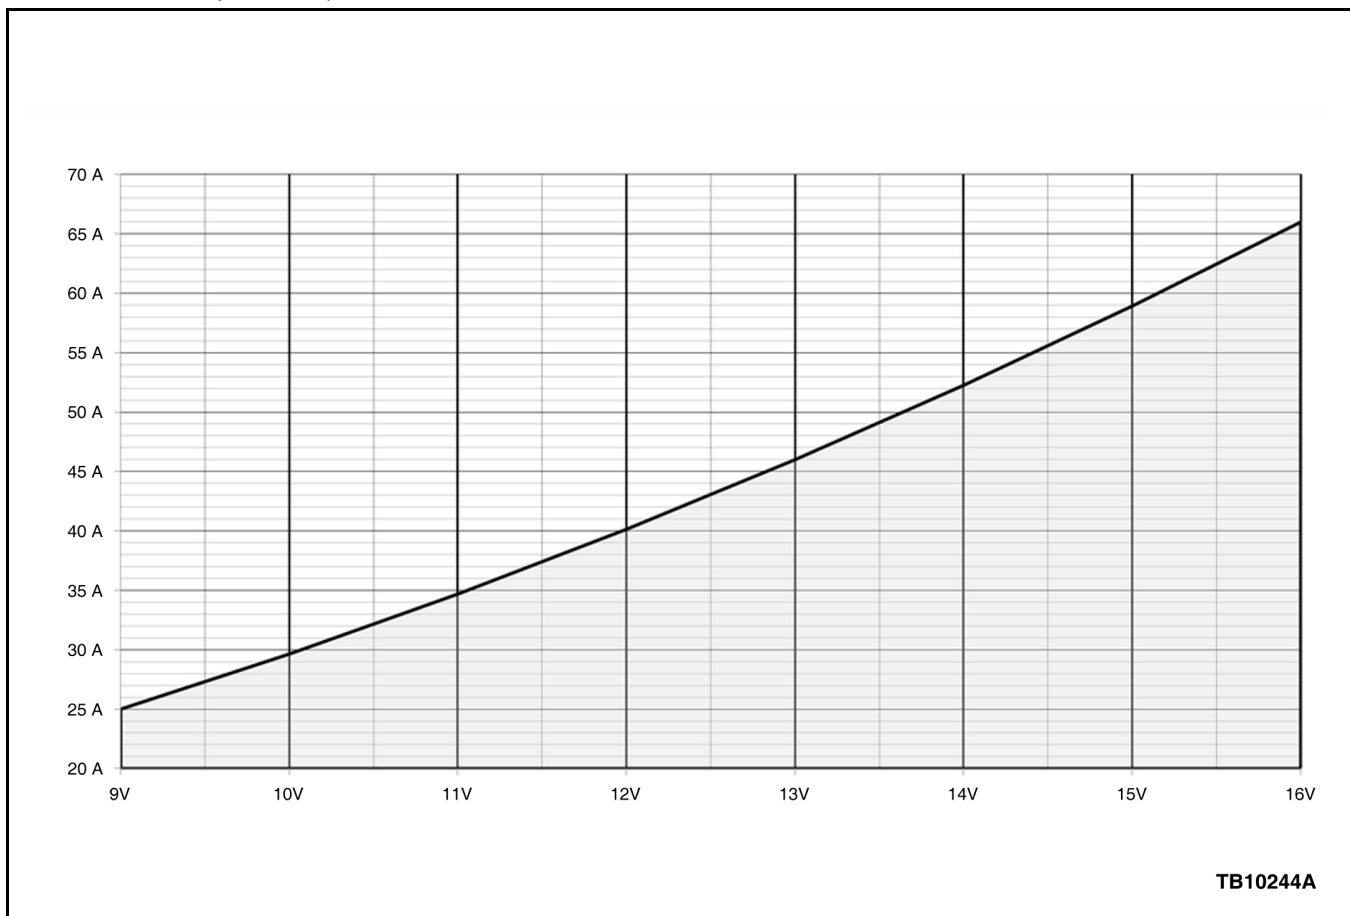
Figure 1 - Article 12-1-14

- d. Compare recorded readings to the chart. (Figure 1) Does your measured reading for voltage and amperage lie within the shaded area of the graph shown? (Figure 1)

- (1) Yes - Do not replace the cooling fan. Fan operating as intended. Proceed to Step 5.
 - (2) No - Replace the cooling fan and shroud assembly. Proceed to Step 5.
