LINCOLN:
2012 MKS

TSB 12-5-9 (Continued)

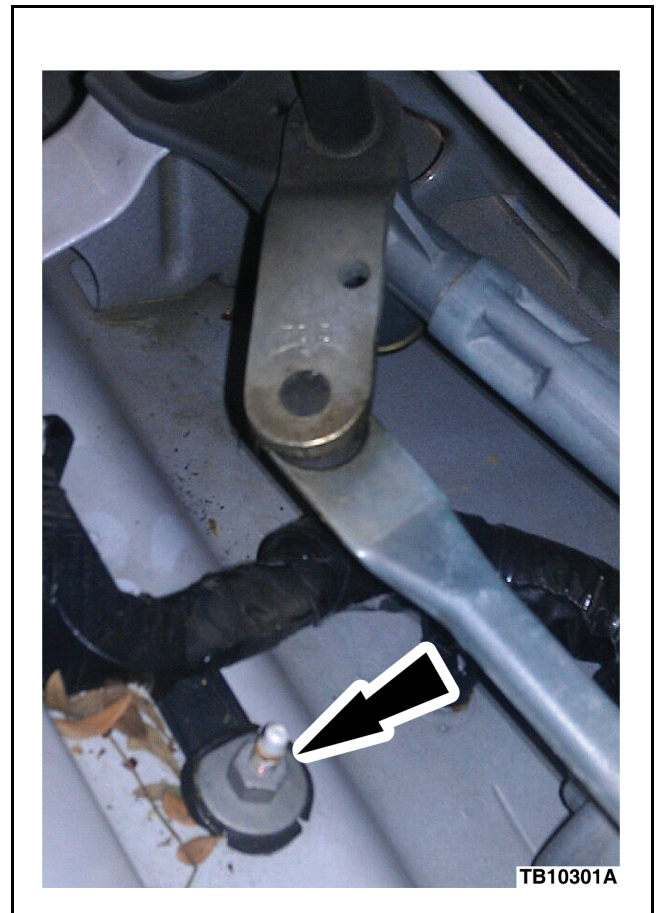
Figure 1 - Article 12-5-9

The windshield wiper pivots on some 2012 MKS vehicles built on or before 2/5/2012 may chafe the 14290 harness. Driveability symptoms may indicate this condition exists.

1. Remove the cowl panel grill, refer to Workshop Manual (WSM), Section 501-02.
2. Inspect the 14290 harness for possible chaffing at the windshield wiper pivots.
 - a. If harness is not damaged, this article does not apply.
 - b. If harness is damaged at the wiper pivots proceed to Step 3.
3. Repair harness damage following wiring repair guidelines found in the Wiring Diagrams cell 5-1.
4. Secure harness to the retention features in the cowl area. (Figure 1)
