SERVICE BULLETIN

APPLICABILITY: 2015-16MY Legacy and Outback Models
SUBJECT: Service Procedure to Address a Wind Rushing Sound from the Front Door Sash Area

NUMBER: 12-176-14R
DATE: 12/05/14
REVISED: 10/28/15

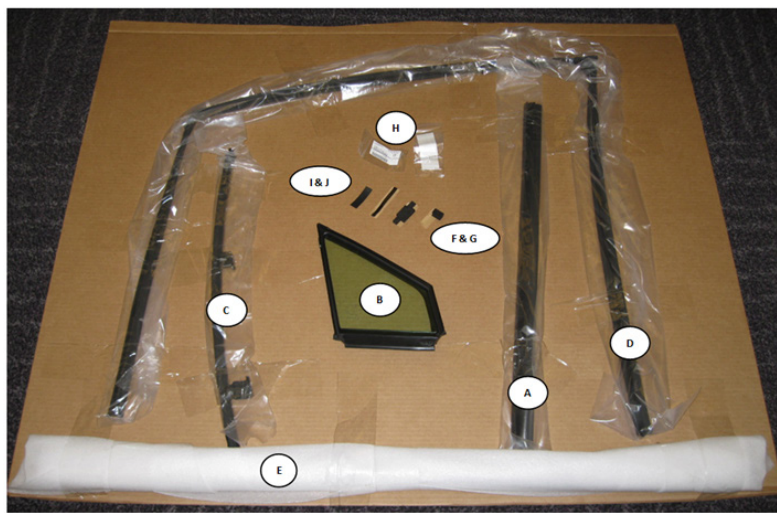
NOTE: If you have in stock or receive a repair kit with an 80mm section of butyl tape included (item “J” in the photo below), a much longer, **(320mm)** section, p.n. **SOA635138** must be ordered to properly complete these repairs. All repair kits with a Pack Date after May 1st, 2015 will include the longer **320mm section** of butyl tape. The repair kit part numbers will remain unchanged.

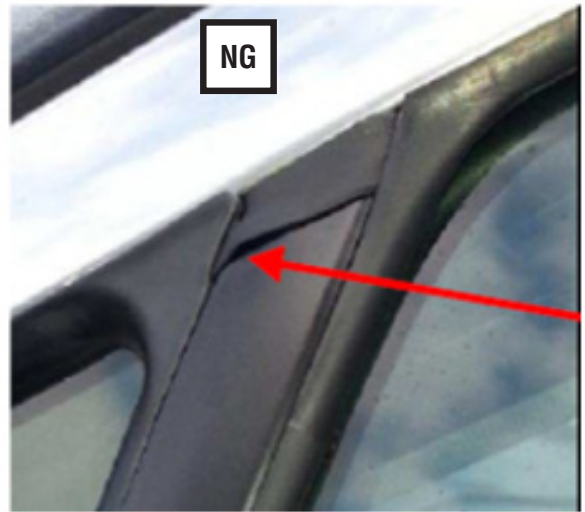
- Before torquing the sash hardware, inspect the partition glass weatherstrip / seal closely for proper fit with no gaps or bunching up of the seal outer lip. An example of a proper and an improper fit are shown below.
