## SERVICE BULLETIN

**APPLICABILITY:** 2015-2016MY Legacy and Outback Models

**NUMBER:** 12-185-15R

**SUBJECT:** Wind “Rushing” or “Fluttering” Sound from “B” Pillar Area

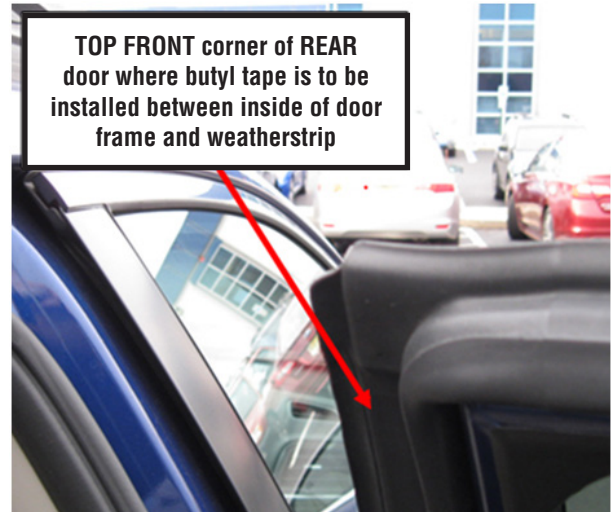
This bulletin provides a repair procedure to address a wind rushing and / or fluttering-type sound originating from the “B” pillar area of the vehicle. The sound is usually reported to be more prevalent when crosswinds are present and / or at highway speeds. The procedure involves the installation of a longer, 320mm piece of butyl adhesive to secure the upper front corner area of the rear door frame weatherstrip. To address customer concerns of a wind rushing sound coming from the front and / or rear door sash area, see TSBs 12-176-14R and 12-177-14R.
