NUMBER: 13-001-01

Creak-Like Sound Coming From Front End Of Vehicle

2002 (KJ) Liberty

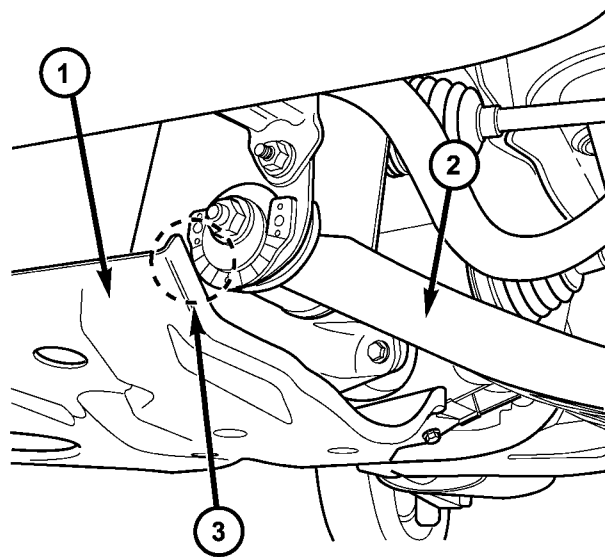
Fig. 1 FRONT SKID PLATE

The vehicle may exhibit a creak-like sound that originates from the front end of the vehicle. This creak-like sound may occur when the vehicle operator either applies the brakes at slow speeds, or when a slow speed turn is made (similar to what may occur during a parking lot maneuver). In a few instances the condition has been described as a pop-like sound.

Determine if the left forward corner of the front skid plate has made contact with the front crossmember. Refer to the figure below for illustration of the possible contact area. If evidence of contact is present perform the Repair Procedure.

- 1 - Front Skid Plate
- 2 - Left Front Lower Control Arm
- 3 - Location Of Contact Between Front Skid Plate and Front Crossmember

1. Loosen, but do not remove, the four skid plate attaching bolts.
2. Slide the front skid plate as far to the right (passenger side) of the vehicle as is possible. While holding the skid plate in place, tighten the four attaching bolts.
3. With the front skid plate repositioned to the right side, measure the clearance between the left forward corner of the front skid plate and the front crossmember (Fig. 1).

4. If a clearance of 3.1 mm (1/8 in.) or more is now present between the front skid plate and the front crossmember, tighten the front skid plate attaching bolts to 61 Nm (45 ft. lbs.). A new front skid plate is not required.
5. If the clearance between the front skid plate and front crossmember is less than 3.1 mm (1/8 in.), install a new front skid plate.
6. Position the new front skid plate to right side and tighten the front skid plate attaching bolts to 61 Nm (45 ft. lbs.).

NOTE: THE TECHNICIAN SHOULD BE AWARE THAT WHEN A FRONT SKID PLATE IS INSTALLED FOLLOWING ANY SERVICE ACTIVITY, THE SKID PLATE SHOULD BE POSITIONED AS FAR TO THE RIGHT SIDE OF THE VEHICLE AS IS POSSIBLE. THIS SHOULD HELP PREVENT POSSIBLE CONTACT BETWEEN THE FRONT SKID PLATE AND THE FRONT CROSSMEMBER.
