MOTORHOME AND COMMERCIAL CHASSIS—MIL AND WRENCH LAMP—BATTERY JUNCTION BOX FUSE 3 OPEN—BUILT ON 1/19/2010 AND THROUGH 12/18/2012

TSB 13-4-8

2011-2012 F-53 Motorhome Chassis,
F-59 Commercial Stripped Chass

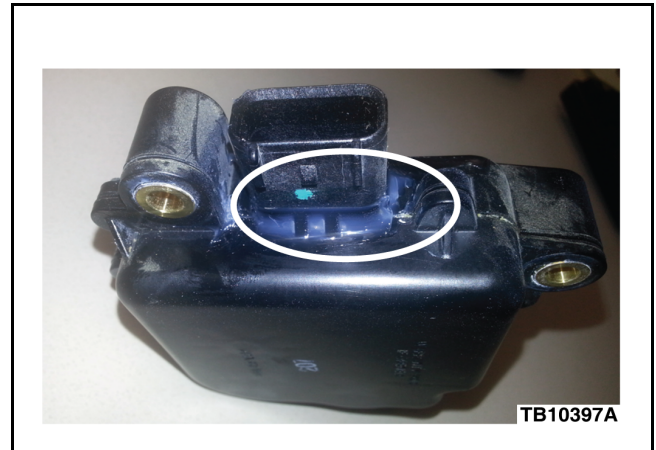
Figure 1 - Article 13-4-8

Some 2011-2012 Motorhome and Commercial Chassis built on 1/19/2010 and through 12/18/2012 may exhibit illuminated malfunction indicator lamp (MIL) and wrench light, with open battery junction box (BJB) fuse 3. Various diagnostic trouble codes (DTCs) may be present in the powertrain control module (PCM). This concern may be due to moisture accumulation in the intake manifold runner control (IMRC).

1. Replace the IMRC. Refer to Workshop Manual (WSM), Section 303-01.
 - a. Remove the IMRC actuator rod C-clip.
 - b. Remove the three (3) bolts and the IMRC actuator.
2. Apply a bead of Motorcraft® Clear Silicone Rubber around the base of the IMRC electrical connector. (Figure 1)

3. Install the IMRC.
 - a. Position the IMRC actuator and install the three (3) bolts. Tighten to 10 N•m (89 lb-in).
 - b. Install the IMRC rod C-clip.
4. Replace BJB fuse 3.
