**MALFUNCTION INDICATOR LAMP (MIL)
ILLUMINATED—DTCs P0135 AND P0155— BUILT ON
OR BEFORE 11/31/2011**

TSB 13-5-7

FORD:
2012 Expedition

LINCOLN:
2012 Navigator

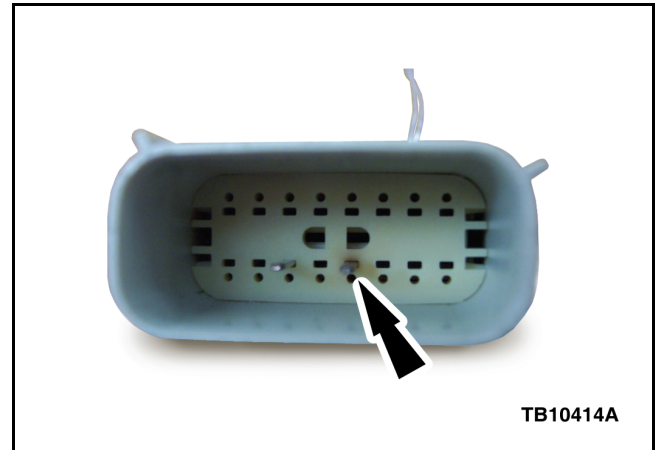
Figure 1 - Article 13-5-7

1. Retrieve all DTCs in the Powertrain Control Module (PCM). Are DTCs P0135 and P0155 present?
 - a. Yes - proceed to Step 2.
 - b. No - this article does not apply. Refer to Powertrain Control/Emissions Diagnosis (PC/ED) Manual for normal diagnostics.
2. Locate C146 in the right rear corner of the engine compartment. Separate the connector and inspect the pins carefully for signs of contamination, discoloration and/or moisture intrusion. Refer to Wiring Diagram, Section 152-1. (Figure 1)

3. Is contamination present?
 - a. Yes - proceed to Step 4.
 - b. No - this article does not apply. Refer to PC/ED Manual for normal diagnostics.
4. Replace connector pigtails on both the female and male sides following desired splicing method. Refer to Wiring Diagram, Section 5-1.
5. Apply Motorcraft® Electrical Grease to the connector terminals.
6. Install the original harness retainer on the male connector and secure the harness.
