FORD:
2013 Fusion

TSB 13-5-24 (Continued)

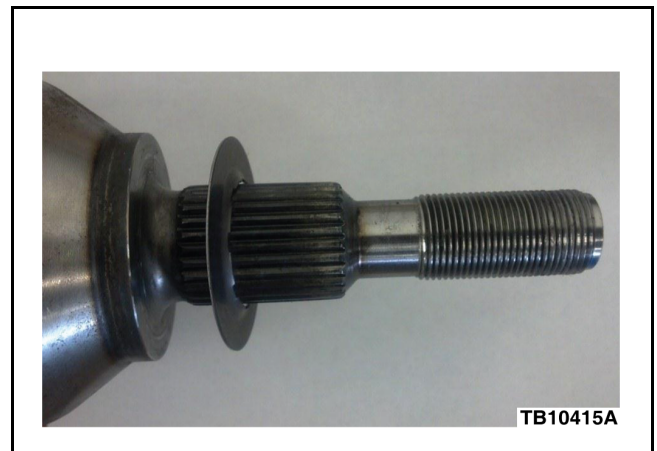
Figure 1 - Article 13-5-24

Some 2013 Fusion, Fusion Hybrid and Fusion Energi vehicles may exhibit a noise that could be described as a ting, pop or click-type noise from the front wheel area when accelerating from a stop or when shifting between drive/reverse and reverse/drive.

- a. Do not remove halfshafts from transmission or power transfer unit.
3. Install one (1) thrust washer over the halfshaft splines until the metal ring is flat against the wheel bearing mating surface. The taper should face outward toward the hub/splines. (Figures 2 and 3)
