**LINCOLN:**  
2013 MKZ

**ISSUE**

## TSB 13-5-26 (Continued)

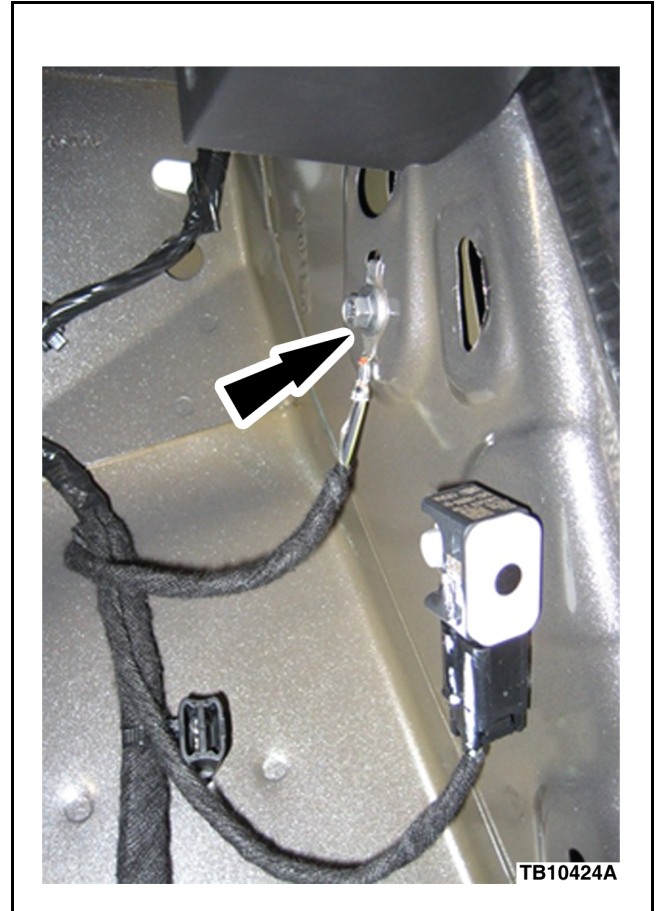
Figure 1 - Article 13-5-26

Some 2013 MKZ vehicles built on or before 3/6/2013 may exhibit various drivability symptoms including a crank no start with diagnostic trouble code (DTC) U0109 stored in the powertrain control module (PCM).

1. Remove the left hand (LH) C-pillar lower trim panel. Refer to Workshop Manual (WSM), Section 501-05.
2. Remove G304 fastener and discard. Refer to Wiring Diagram, Section 10-1. (Figure 1)
3. Install new fastener. Torque to 12 N•m (9 lb-ft).
4. Install LH C-pillar lower trim panel. Refer to WSM, Section 501-05.
5. Clear DTCs.
