**2.0L GTDI—MALFUNCTION INDICATOR LAMP (MIL)—  
DIAGNOSTIC TROUBLE CODE (DTC) P144C—  
VEHICLES BUILT ON OR BEFORE 10/1/2011**

**TSB 13-5-29**

**FORD:**  
2012 Explorer

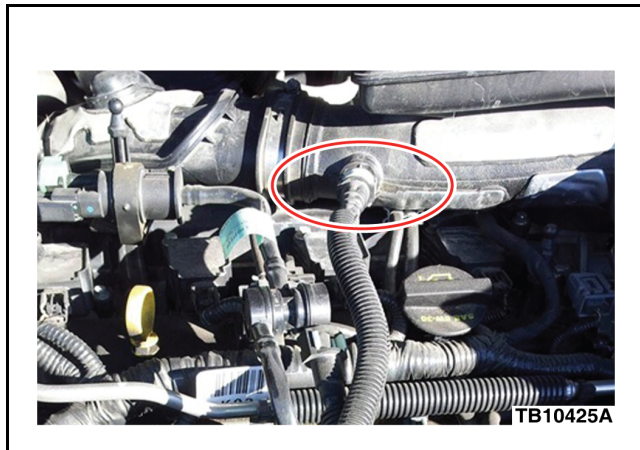
Figure 1 - Article 13-5-29

Some 2012 Explorer vehicles built on or before 10/1/2011 and equipped with a 2.0L Gasoline Turbocharged Direct Injection (GTDI) engine may exhibit an illuminated MIL with DTC P144C. This may be due to a blocked vapor purge line port in the air cleaner outlet pipe assembly.

1. Disconnect battery ground cable. Refer to Workshop Manual (WSM), Section 414-01.
2. Disconnect evaporative emission fuel vapor tube quick connect coupling from the air intake duct center section. Refer to WSM, Section 303-13. (Figure 1)

3. Insert a 5.0 mm (.197”) drill bit or equivalent diameter gauge into the vapor purge line port on the air intake duct center section to determine if it is blocked by plastic flashing. A 5.0 mm (.197”) minimum opening is required for proper Evaporative Emission system operation during boost.
4. Does drill bit or equivalent diameter gauge pass through vapor purge line port?
  - a. Yes - this article does not apply. Connect evaporative emission fuel vapor tube to air intake duct center section and reconnect the battery ground cable. Refer to Powertrain Control/Emissions Diagnosis manual for normal diagnostics.
  - b. No - proceed to Step 5.
5. Replace air cleaner outlet pipe assembly. Tighten all fasteners to 5 N•m (44 lb-in). Refer to WSM, Section 303-12.
6. Connect evaporative emission fuel vapor tube to air intake duct center section and battery ground cable.
