3.5L GTDI—INTERMITTENT MIL ILLUMINATED WITH ONE OR MORE OF THE FOLLOWING DTCS P0236, P0238, P025E AND/OR P007D—BUILT ON OR BEFORE 2/15/2013

TSB 13-10-10

2011-2013 F-150

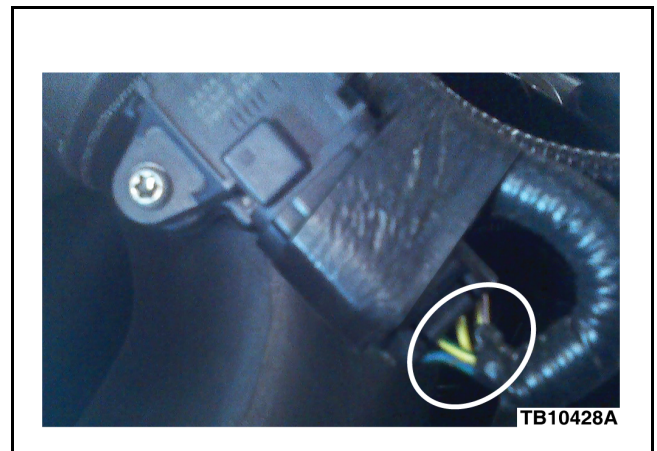
Figure 1 - Article 13-10-10

Some 2011-2013 F-150 vehicles built on or before 2/15/2013 and equipped with a 3.5L Gasoline Turbocharged Direct Injection (GTDI) engine may exhibit an intermittent malfunction indicator light (MIL) illuminated with one or more of the following diagnostic trouble codes (DTCs); P0236, P0238, P025E and/or P007D.

1. Using Integrated Diagnostic System (IDS), retrieve DTCs.
2. Are one or more of the following DTCs stored in the Powertrain Control Module (PCM); P0236, P0238, P025E and/or P007D?
 - a. Yes - proceed to Step 3.
 - b. No - this article does not apply. Refer to Powertrain Control/Emissions Diagnosis (PC/ED) manual for normal diagnosis.
3. Inspect for damage the wiring harness at the Turbocharger Boost Sensor connector C1588 for crack to wiring insulation. (Figure 1)
4. Is the wiring insulation damaged?
 - a. Yes - proceed to Step 5.
 - b. No - this article does not apply. Refer to PC/ED manual for normal diagnosis.
5. Install connector pigtail. Refer to splicing methods in Wiring Diagram, Section 5-1.
6. Using electrical tape, retain the harness to the connector shell with enlarged loop. (Figure 2)
