**FORD:**

2013-2014 Escape

**ISSUE**

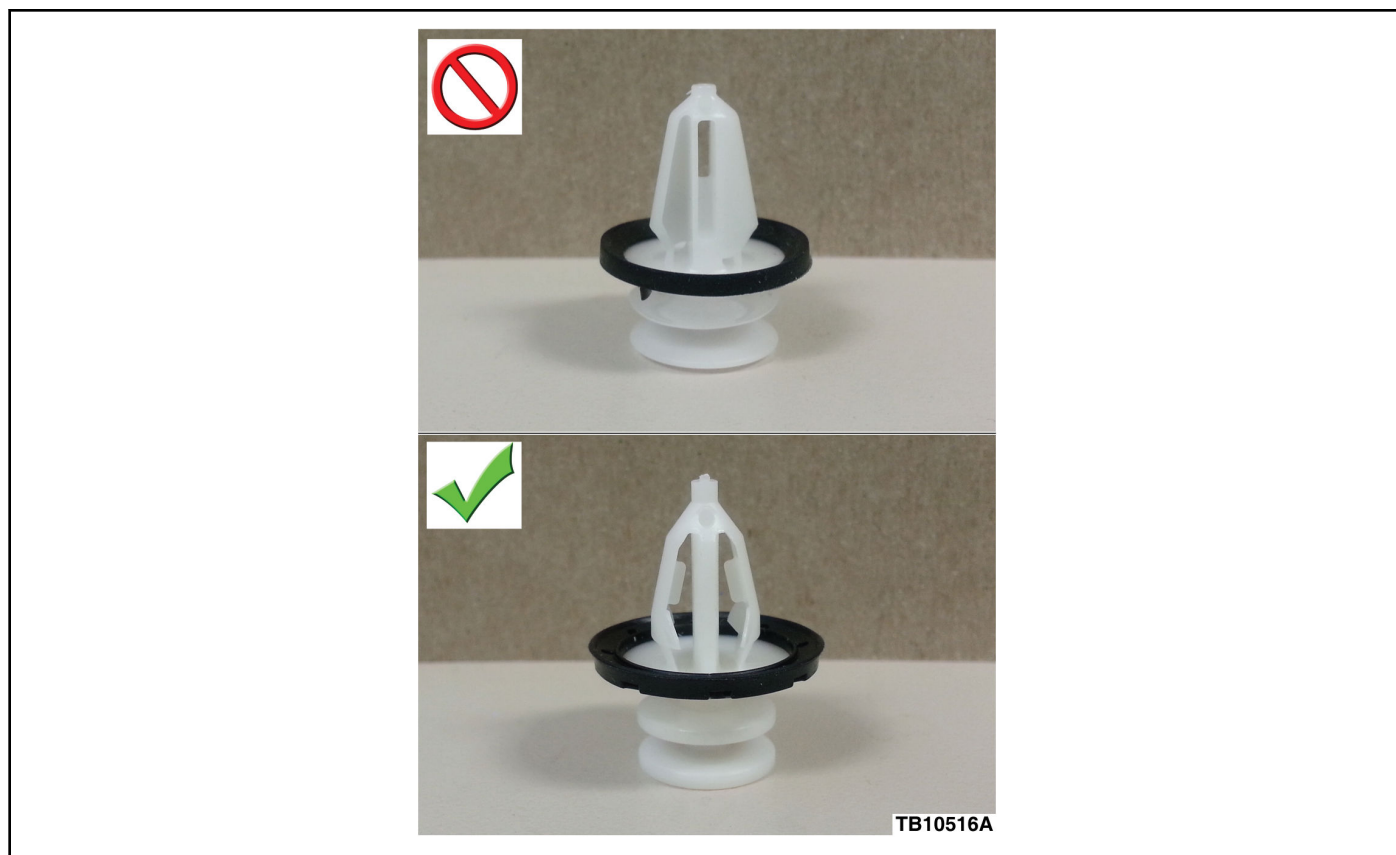
Figure 1 - Article 14-0004

Some 2013-2014 Escape vehicles built on or before 9/13/2013 may exhibit loose attachment of the left or right rear door trim panel, typically near the bottom of the door. A new retaining clip is now available for service.

1. Is the affected rear door trim panel damaged as a result of the loose attachment?
  - a. Yes - replace the rear door trim panel. Refer to Workshop Manual (WSM), Section 501-05. Use new style retaining clips on new door panel. (Figure 1) Repair is complete.
