2011-2012 Taurus

2011-2012 Explorer, Flex

This article supersedes TSB **13-12-21** to update the vehicle application.

ISSUE

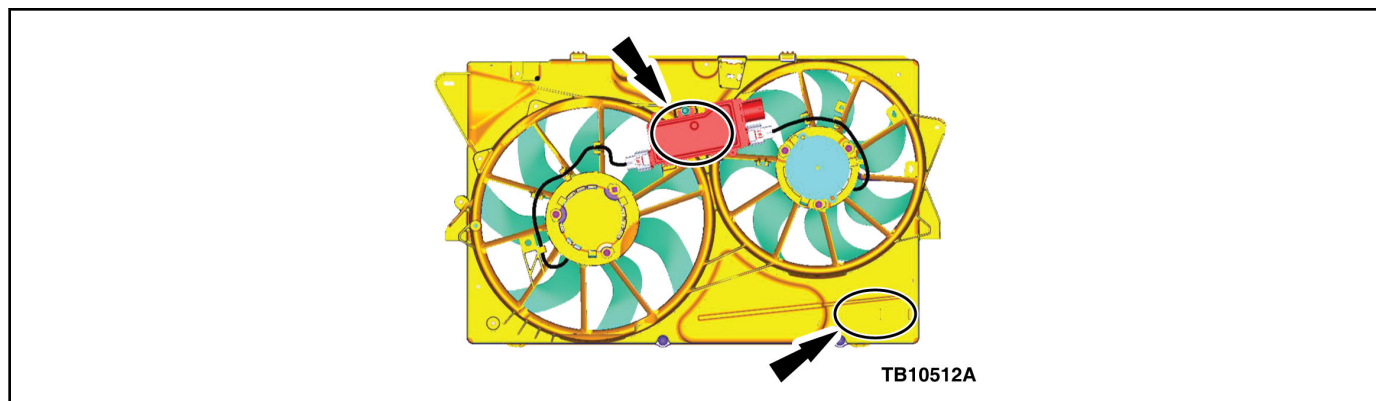
Figure 1 - Article 14-0019

- a. No – please be sure to check the fan assembly for being original equipment manufacturer (OEM). (Figure 1)

- (1) For Taurus and MKS vehicles, replace the cooling fan motor and control module assembly. Refer to Workshop Manual (WSM), Section 303-03 and then proceed to Step 5.
 - (2) For Explorer, Flex and MKT vehicles, proceed to Step 3.
- b. Yes - this article does not apply. Refer to WSM, Section 303-03 for normal diagnostics.
3. Remove the cooling fan motor and control module assembly. Refer to WSM, Section 303-03.
 4. Remove the cooling fan control module from the original cooling fan motor assembly and transfer onto the new cooling fan motor assembly. Tighten screw to 7 Nm (60 lb-in).
 5. Install the new cooling fan motor assembly. Refer to WSM, Section 303-03.
 6. Check coolant level and top off as necessary using the correct coolant type. Refer to WSM, Section 303-03.
