FORD:

2013-2014 Escape

This article supersedes TSB **13-5-23** to remove the production fix date, update the vehicle model years, Service Procedure and Part List.

TSB 14-0111 (Continued)

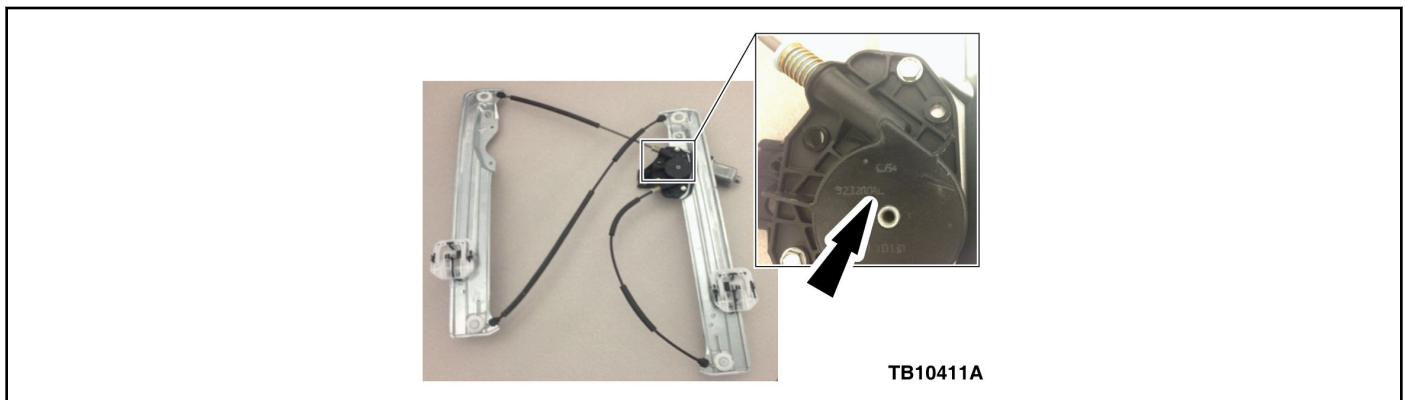
Figure 1 - Article 14-0111

1. Remove the front window glass on the affected door(s). Refer to Workshop Manual (WSM), Section 501-11.
2. Determine the build date of the vehicle.
 - a. If the vehicle was built on or before 2/4/2013 proceed to Step 3.
 - b. If the vehicle was built on or after 2/5/2013 perform only Step 6.
3. Locate the part number on the window regulator. Is the suffix AG or higher. (Figure 1)

- a. Yes - proceed to Step 4.
 - b. No - replace the window regulator. Refer to WSM, Section 501-11.
4. Remove and discard the foam patch at the bottom of the front window glass run at the A-pillar.
5. Replace the interior front door lower beltline moulding.
6. Replace the door glass run seal. (Figure 2)
