FORD:

2013-2014 C-MAX

ISSUE

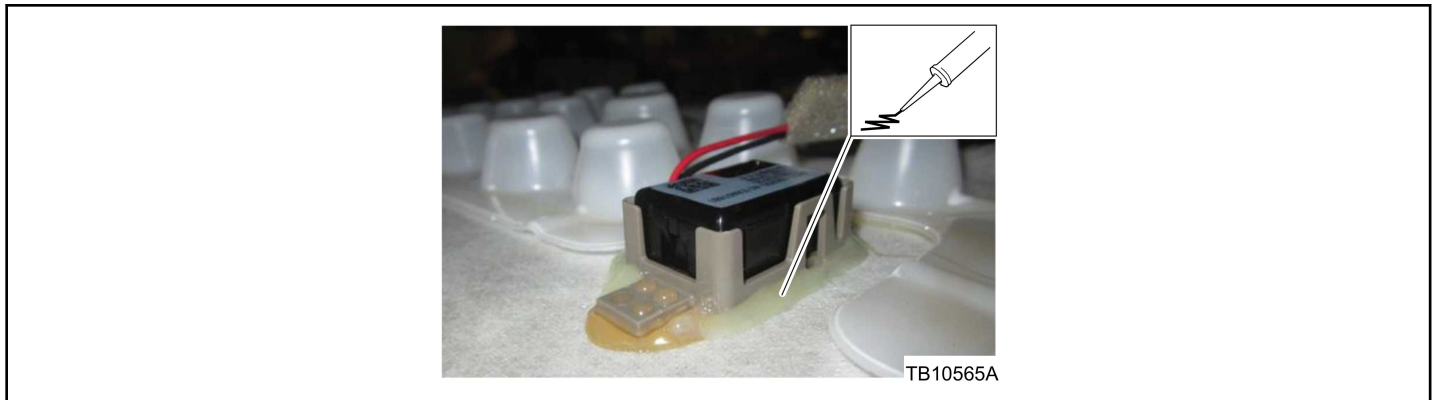
Figure 1 - Article 14-0151

Some 2013-2014 C-MAX Hybrid and C-MAX Energi vehicles may exhibit a loud, low frequency, droning powertrain type noise when the engine is running. The noise can be intermittent and may be heard mostly at specific speeds, RPM ranges, and vehicle loads, such as while driving up a hill or grade. The vehicle is equipped with ANC that uses the vehicle's sound system to cancel out specific low frequency powertrain noises.

- a. Perform an IDS on-demand self-test on the DACMC.
 - b. Did DTC B13F5-01 set in the DACMC?
 - (1) Yes - clear the DTC and reconnect the microphone. Proceed to Step 8.
 - (2) No - disconnect the wire harness from the microphone and reposition the wire harness to connect the harness to the correct microphone, so the fault codes match the microphone position. Clear the DTC. Proceed to Step 8.
8. Fully seal each microphone bezel to the headliner using 3M™ Super-Fast Adhesive. (Figure 1)
