**FORD:**

2011-2012 F-150, Mustang

## TSB 14-0156 (Continued)

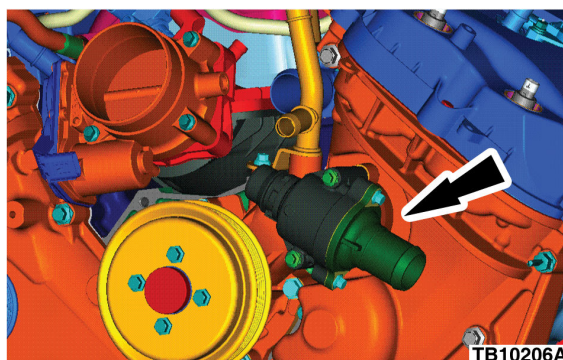
Figure 1 - Article 14-0156

Some 2011-2012 F-150 and Mustang vehicles (excluding Boss) equipped with a 5.0L engine may exhibit an intermittent metallic rattle or scratching type noise in the area at the front of the left hand (LH) or driver side cylinder head at idle with the engine at operating temperature.

3. Using a mechanic's stethoscope or EngineEAR, listen for a metallic type rattle or scratching type noise at the front of LH cylinder head. Is the noise heard in areas shown? (Figures 1 and 2)

- a. Yes - replace the left hand primary tensioner and timing chain tensioner arm using the kit part number provided in this article. Refer to WSM, Section 303-01.
- b. No - this article does not apply. Refer to WSM, Section 303-00 for normal diagnostics.

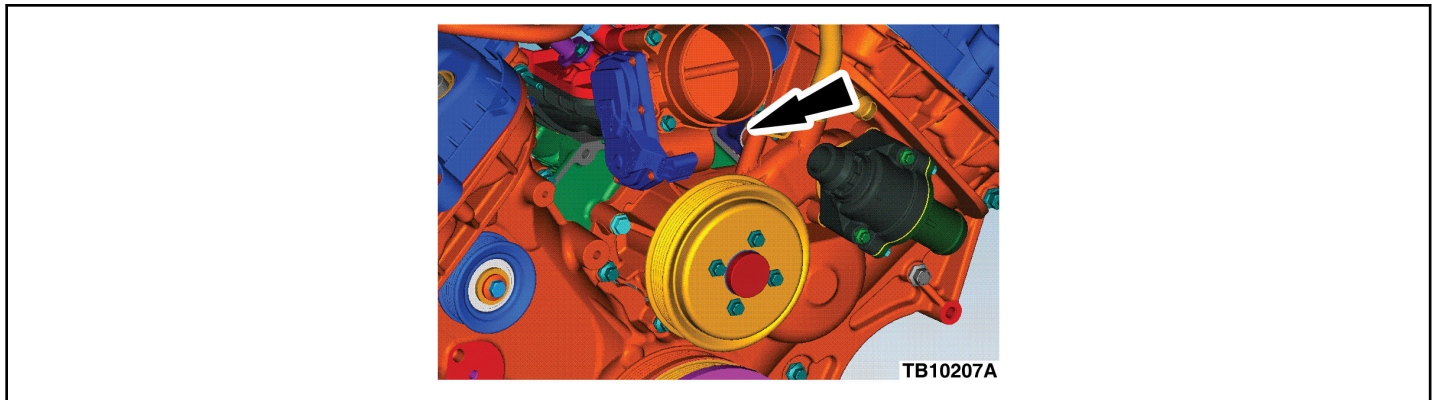
Figure 2 - Article 14-0156

- a. Yes - proceed to Step 5.
  - b. No - replace the coolant pump. Refer to WSM, Section 303-03. Repair is complete.
5. Is the noise heard in the areas shown? (Figures 1 and 2)
