To All Lamborghini Dealers and Licensed Service Point  
From Customer Service Department  
Subject Service campaign - New Routing for Gallardo E-Gear hydraulic pipes  
Group 140.3.01.00.05  
Date 18.07.2005  
Pages 4

New routing for the Gallardo E-Gear hydraulic pipes

Only Gallardo E-Gear models until VIN ZHWG\_11S\_5LA02466

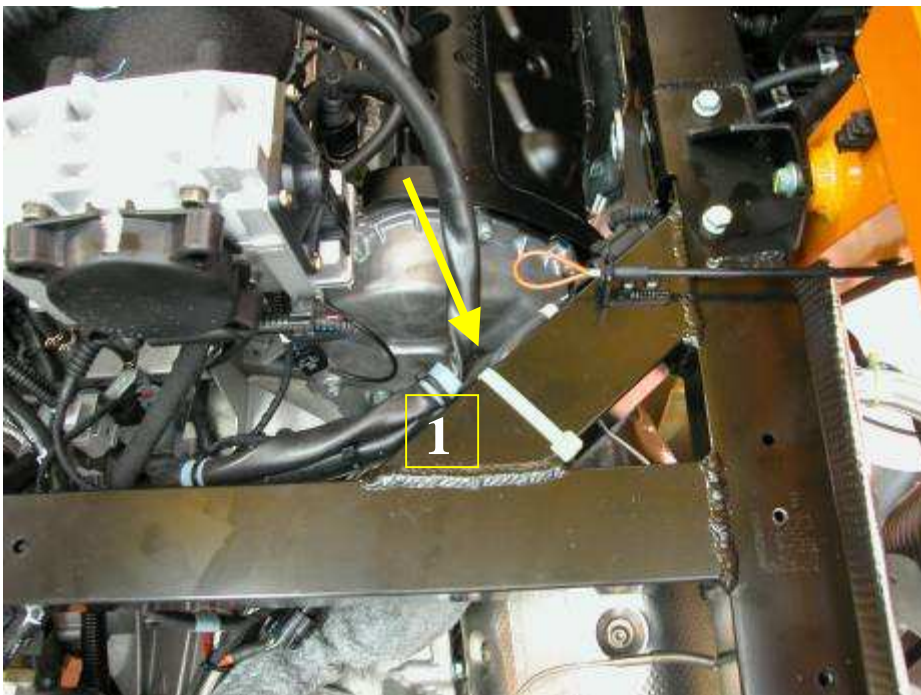
Picture 3

1.3 Picture number 3 indicates the first clamp to be replaced

1.2 You will need to replace the old clamps with new clamps.

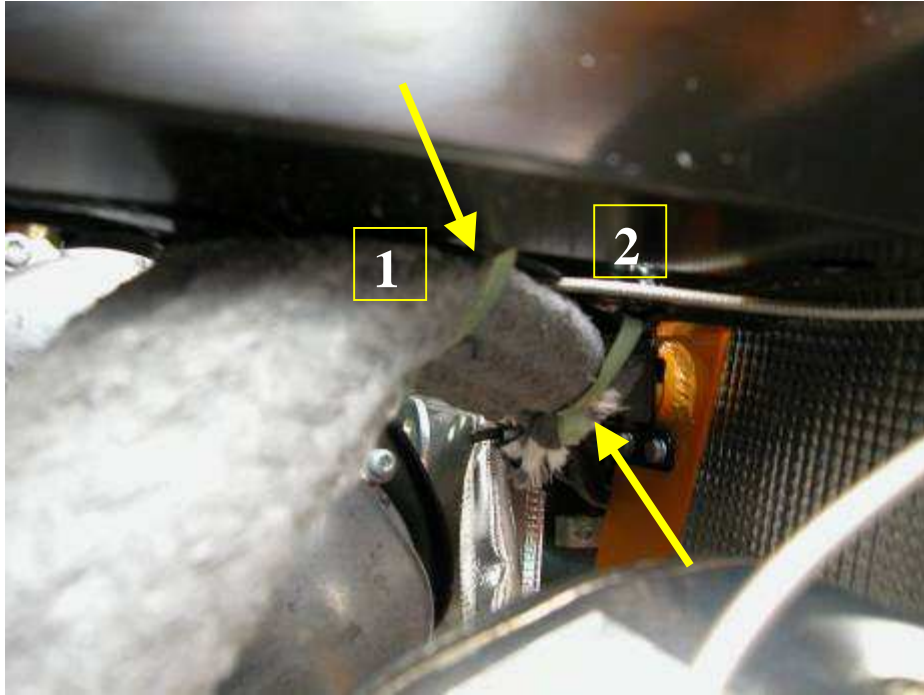
1.4 Picture 4 indicates the 2<sup>nd</sup> clamp to be replaced.
