Subject Rear drive shafts

Group 140.3.07 Date 21.05.2007

Rear drive shafts

Gallardo (Coupè and Spyder) from VIN 4460 to VIN 5690

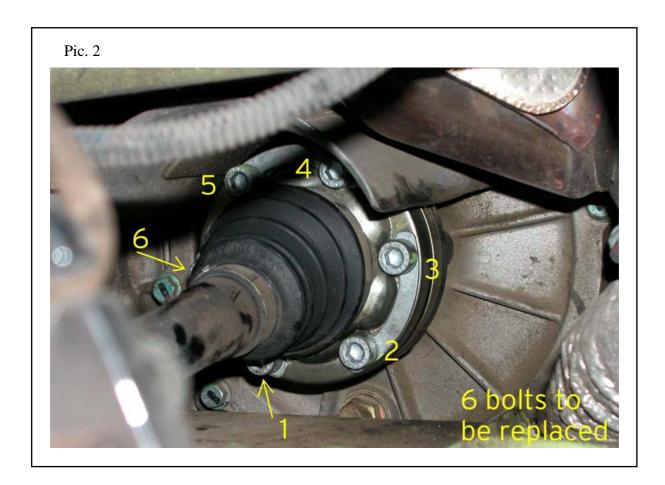
A change in the production procedure has caused in single cars a reduced tightening torque at the bolts in the rear differential drive shafts. This could cause noise while driving.

1.5 As shown in picture 2, you have to replace all the 6 bolts on the shaft on both transmission side, totally 12 bolts per car.

- **1.6** Unscrew all the six bolts on the driveshaft.
- **1.7** Replace the old bolts with the new ones of the rework kit 0R1400150. The kit contains 12 bolts.
