Subject Knocking noise form the torsion bar support.

Group 140.4.01.00.04.TorsionBar.GB

Automobili Lamborghini S.p.A.

Gallardo until VIN ZHWG_11__4LA01398

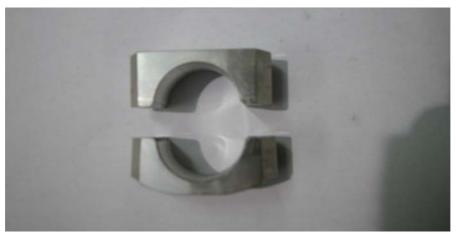
Pic 1

Front axle: Rubber bushes (quantity 2 pcs) – 400411324C **Rear axle**: Rubber bushes (quantity 2 pcs) – p/n 400511324C

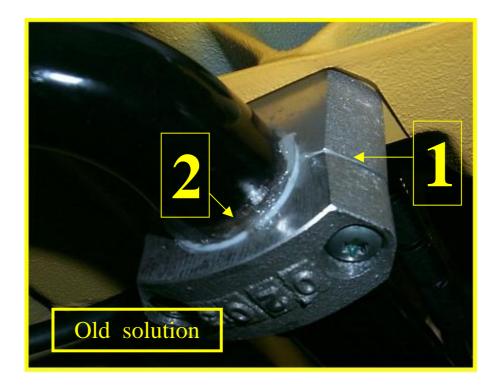
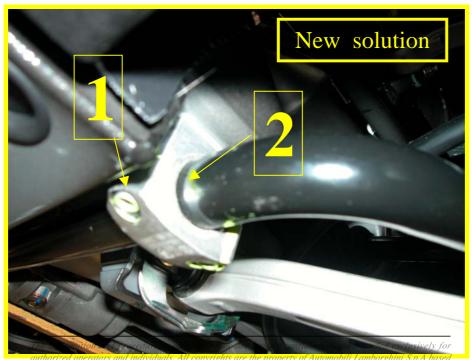
- **1.1** Adopt all precautions to prevent car damages and to work safe.
- **1.2** Raise the car on the lift.
- **1.3** Now you can individuate the parts you need to replace. You need to replace four brackets (n.1) and four bushes (n.2). (pic.1)

- **1.4** Disconnect the sway bar from the drop links.
- 1.5 Remove bracket (1) and bush (2).1.5A clean the surfaces in contact between the sway bar and the new rubber bushes.
- **1.6** Replace the nylon bushes with the rubber bushes
- **1.7** Replace brackets with new ones.
- **1.8** Apply medium thread lock agent on fixing bolts.
- **1.9** Tighten the cap bolts at 10nm.
- **1.10** Reconnect the sway bars to the drop links.
