**FORD:**

2012-2014 Focus

This article supersedes TSB **14-0215** to update the Service Procedure.

**ISSUE**

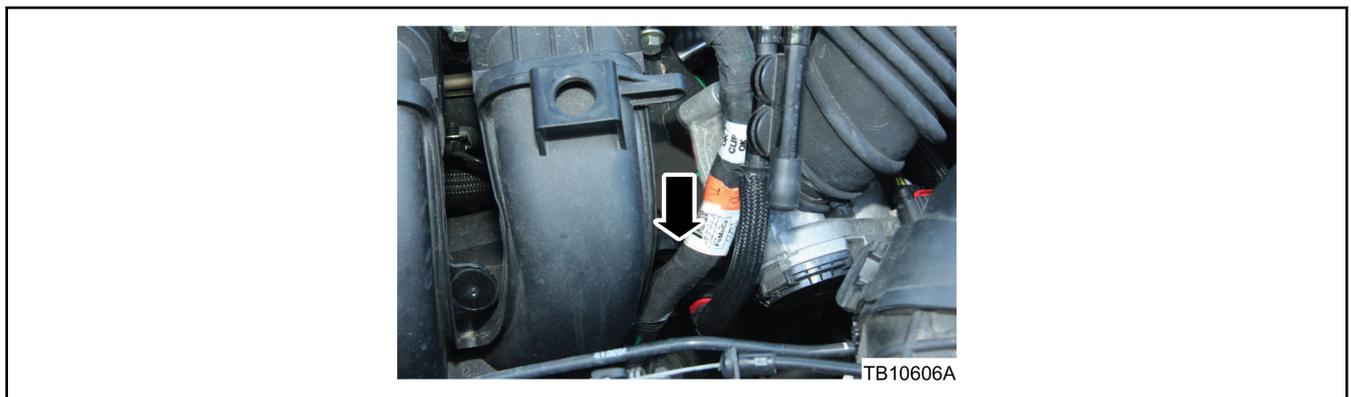
Figure 1 - Article 15-0036

1. Check the vehicle build date. Was the vehicle built on or before 2/4/2014 with an automatic transmission or built on or before 2/19/2014 with a manual transmission?
  - a. Yes - inspect the engine harness for chafing against the intake manifold, near the throttle body. (Figure 1)

- (1) It may be necessary to use a small mirror to inspect the back side of the harness where the harness may contact the intake manifold. Proceed to Step 2.
  - b. No - proceed to Step 5.
2. Does the wiring harness protection show damage, abrasion or chafing against the intake manifold?

- a. Yes - remove the harness protection to inspect for damaged circuits. Repair any damaged circuits.
  - (1) When repairing damaged circuits, it is necessary to first disconnect the electrical connectors for the HPP, MAF/IAT, EVAP purge valve, ECT, HO2S11, HO2S12, FRP, CMP11, CMP12, VCT11, VCT12 and all 4 coil on plugs (COPs). Refer to the Wiring Diagram for component locations.
  - (2) Remove the air cleaner assembly. Refer to Workshop (WSM), Section 303-12.
  - (3) Remove the bolt from ground G103.
  - (4) With the engine harness retainers disconnected from the top of the engine, the engine harness can be lifted and moved forward enough to gain access to circuits in the chafing location.
  - (5) Additional wire must be added to the repaired circuits to maintain proper circuit length. Refer to the Wiring Diagram Section 5 and use the solder method. Proceed to Step 3.
