FORD:

2014-2015 Fusion

ISSUE

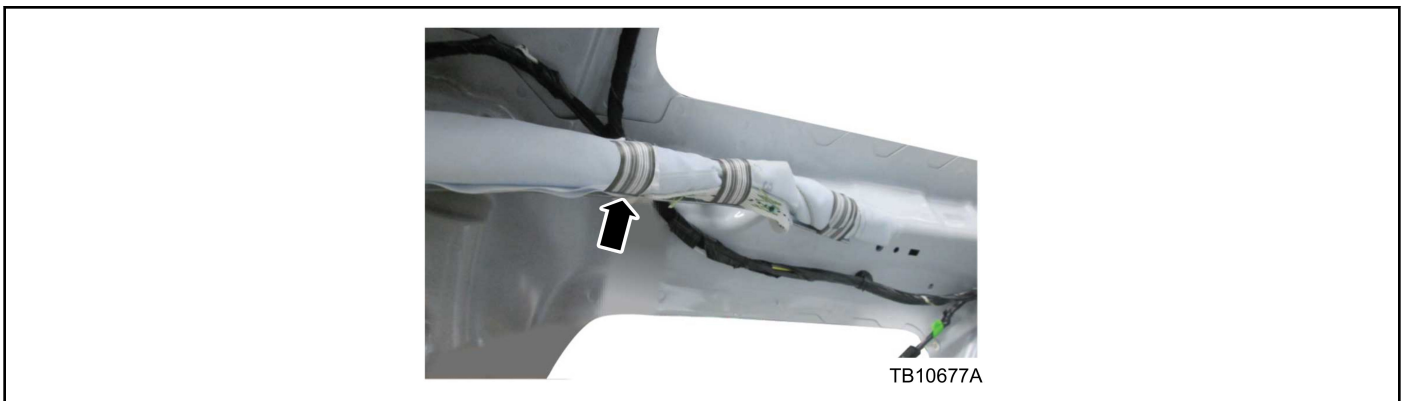
Figure 1 - Article 15-0069

1. Does the first position of the vehicle identification number (VIN) start with a number 1? Refer to Workshop Manual (WSM), Section 100-01.
 - a. Yes - proceed to Step 2.
 - b. No - the vehicle was not built at Flat Rock assembly plant, refer to WSM, Section 501-05 for normal diagnosis.
2. Remove the headliner, refer to WSM, Section 501-05.
3. Without using a cutting tool, hand tear and remove the striped or bar coded piece of tape identified on both the driver and passenger side curtain air bag in the C pillar area. (Figure 1)

- a. When removing the tape it is expected and acceptable for some of the backing or back side of the tape to remain on the curtain air bag. Do not use any chemicals or tools and attempt to remove the backing that remains.
4. Install a new headliner along with updated upper A, B and C pillars which are included in the trim panel kit. Refer to WSM, Section 501-05.
 - a. The original D-pillar trim panel can be reinstalled with a new 2-stage retention clip on each pillar.
5. For 2014 Fusion vehicles install the overhead console attachment kit to the overhead console prior to installing the original overhead console in the new headliner.
