**ADAPTIVE DRIVE MALFUNCTION MESSAGE IN THE INSTRUMENT CLUSTER WITH POSSIBLE DTCS C110D AND/OR C110C - BUILT ON OR BEFORE 5/4/2015**

**TSB 15-0075**

2013-2015 MKS, MKT

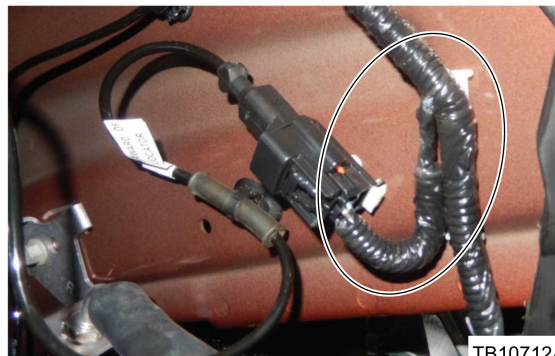
Figure 1 - Article 15-0075

1. Raise vehicle on a hoist, refer to Workshop Manual (WSM), Section 100-02.
2. Remove the front right and front left side wheel and tire per the WSM, Section 204-04.
3. Disconnect connector C1668 on the left front strut assembly and C1669 on the right front strut assembly.
4. Remove the tape and plastic convolute around the take out to connector C1668 and C1669 and the main wire harness, approximately 5.0 cm (2.0") in each direction from the take out. (Figures 1 and 2)

5. Inspect for wire damage to the main harness for any broken or exposed copper under the wire insulation.

6. Isolate any chafed/corroded wiring and replace connector (main harness 14290 side only) C1668 and C1669 with a new pigtail connector. Refer to the wiring repair kit instructions included in the pigtail kit. (Figure 1 and 2)
7. Wrap the main harness wiring 5.0 cm (2") in both directions from the take out and wrap the entire wiring of the new pigtail connectors with Coroplast™ electrical wire harness tape or equivalent. (Figure 1 and 2)
  - a. Normal electrical tape does not have the anti-abrasion properties required to protect the wiring.
8. Replace the original convolute and cover with standard electrical tape.
9. Reconnect connectors C1668 and C1669.
  - a. For MKT make sure the connector take out is routed behind the main wiring harness. (Figure 1)
10. Reinstall the right and left wheel and tire per WSM, Section 204-04.
11. Lower the vehicle.
12. Retrieve and clear any DTCs.
