**FORD:**

2015 Edge

**LINCOLN:**

2015 MKC

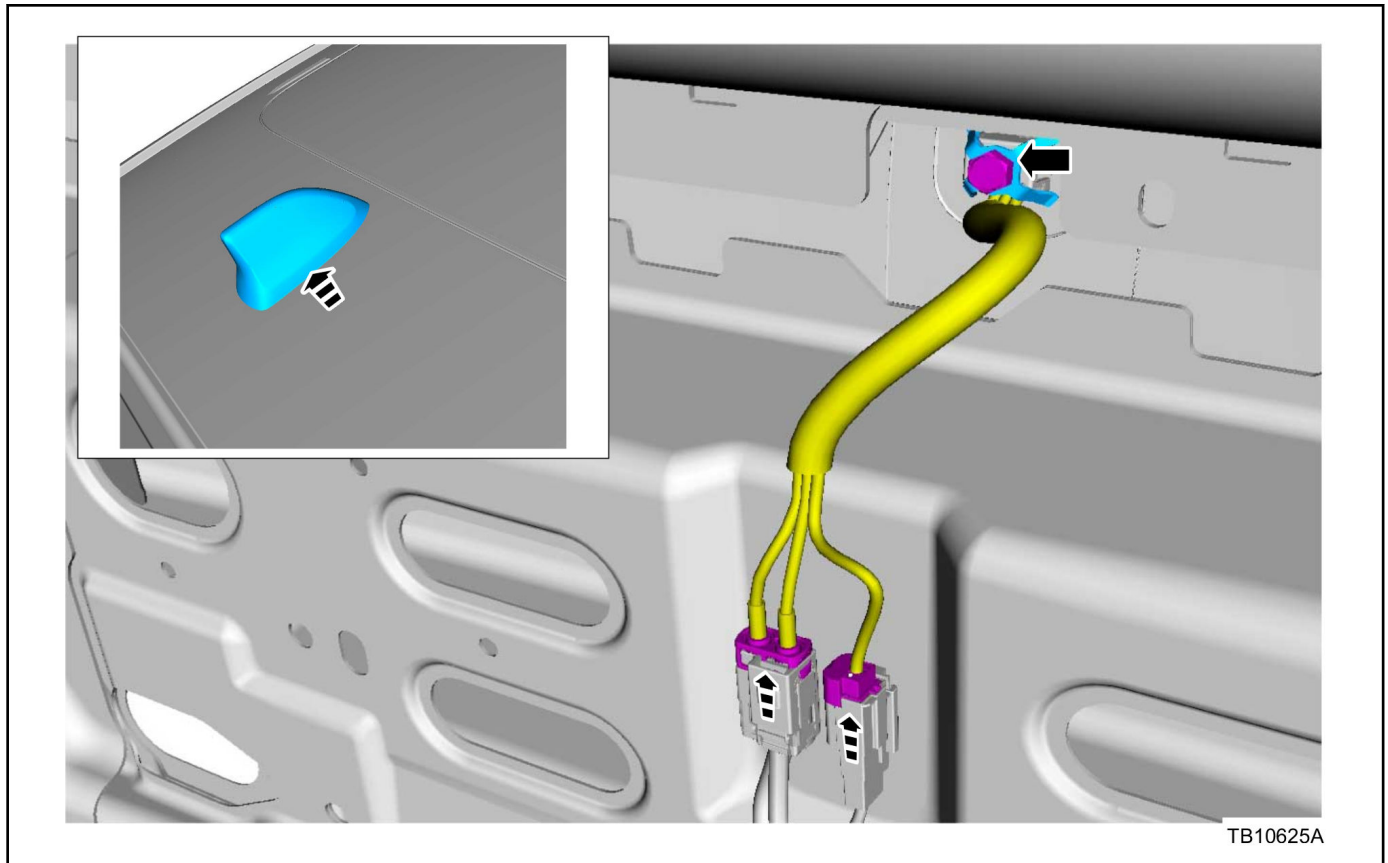
Figure 1 - Article 15-0136

Some 2015 MKC and Edge vehicles equipped with Sirius satellite radio and built on or before 7/14/2015 may exhibit an intermittent concern where the audio cuts out and the radio displays a No Signal message while driving in open sky conditions in certain locations in your area. This may be due to interference with cellular phone tower signals.

- a. Remove the retainer and audio unit antenna and harness through the roof opening. (Figure 1)

- b. The new audio unit antenna must be painted to the vehicle color before installing.  
 c. Tighten the bolt to 7 Nm (62 lb-in.).  
 7. To install, reverse the removal procedure.
