## SERVICE BULLETIN

**APPLICABILITY:** 2014-15MY XV Crosstrek Hybrid (HEV) Models with Fujitsu-Ten (F10) SD Navigation / Audio System      **NUMBER:** 15-176-14R  
**DATE:** 10/15/14  
**SUBJECT:** Audio Volume Level Drops While Driving      **REVISED:** 03/30/15

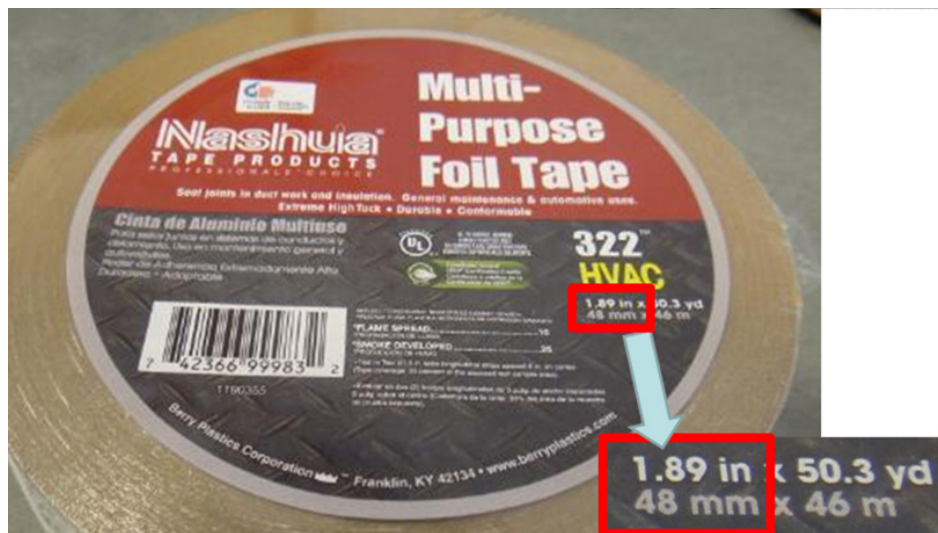
This service procedure involves application of self-adhesive foil tape to “seal” the gaps between the stamped aluminum battery cover and the vehicle body in the areas shown in the photos below.
