**3.7L - ILLUMINATED MALFUNCTION INDICATOR LAMP (MIL) -
DIAGNOSTIC TROUBLE CODE (DTC) P013C - BUILT ON OR BEFORE
4/21/2016**

TSB 16-0078

LINCOLN:
2016 MKX

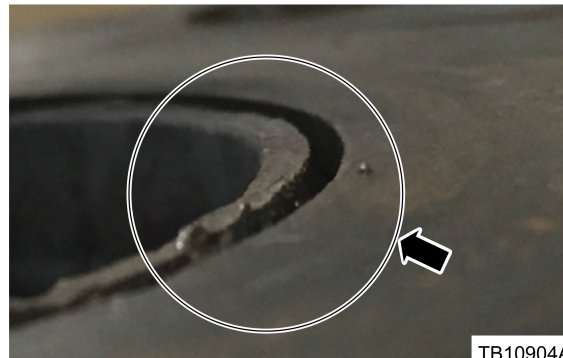
Figure 1 - Article 16-0078

1. Use the Ford Integrated Diagnostic System (IDS) or equivalent scan tool to check for DTCs in the PCM. Is DTC P013C present?
 - a. Yes - proceed to Step 2.
 - b. No - this article does not apply. Refer to the Powertrain Controls and Emissions Diagnostics (PC/ED) manual for normal diagnostics.
2. Remove the exhaust y-pipe. Refer to Workshop Manual (WSM), Section 309-00.
3. Inspect the left side exhaust y-pipe flange sealing area that attaches to the left side catalytic converter for signs of weld slag and/or exhaust pipe intrusion into the flange sealing area. Are sign of weld slag and/or exhaust pipe intrusion present in the flange sealing area? (Figures 1-2)

- a. Yes - proceed to Step 4.
 - b. No - proceed to Step 5.
4. Use a flat file or 60 grit sandpaper on an oscillating sander with a flat pad to remove the weld slag and/or exhaust pipe material protruding above the flange sealing surface.
 - a. Removing too much material from the flange sealing surface may cause additional exhaust leaks.
 5. Check for proper torque of the left side catalyst monitoring sensor (CMS). The CMS should be torqued to 48 Nm (35 lb-ft).
 6. Clean the exhaust y-pipe mounting flanges with a clean microfiber cloth and replace the exhaust y-pipe gaskets.
 7. Reinstall the exhaust y-pipe. Refer to WSM, Section 309-00.
 8. Clear DTCs from the PCM memory.
