FORD:

2015 Edge

TSB 16-0079 (Continued)

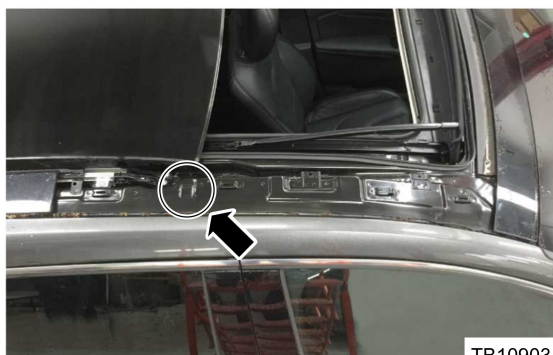
Figure 1 - Article 16-0079

Some 2015 Edge vehicles equipped with a roof opening panel and built on or before 8/10/2015 may exhibit a rattle, pop, tap and/or tick noise coming from the roof at the top of the B-pillar. Noise can be heard above and behind the driver and/or passenger front seats.

1. Does the vehicle exhibit a rattle, pop, tap and/or tick noise at the top of the B-pillar when going over bumps?
 - a. Yes - proceed to step 2.
 - b. No - this article does not apply. Refer to Workshop Manual (WSM), Section 100-04 for normal diagnostics.
2. Position the roof opening panel to the full open position.
3. Remove the roof opening panel side trim panel on the affected side. Refer to WSM, Section 501-17.
4. Locate the roof opening panel net pad. Passenger side shown, driver side similar. (Figure 1)

5. Using a straightedge and a depth micrometer or other suitable measuring device, measure the depth of the roof opening panel net pad in the center of the square. Record the measurement.
6. Place a 2 cm (3/4") brass punch in the center of the roof opening panel net pad.
7. Using a 5 lb. dead blow hammer, hit the brass punch with enough force to indent the roof opening panel net pad sheet metal 2 mm (1/16").
