LINCOLN:
2016 MKX

ISSUE

Some 2016 Lincoln MKX vehicles built on or before 3/21/2016 may exhibit wind noise at the driver and/or passenger A-pillar to windshield area. The noise is most noticeable at highway speeds. This may be due to the windshield A-pillar moulding not being properly adhered to the A-pillar sheet metal and/or from the shape of the channel that runs inside the windshield moulding.

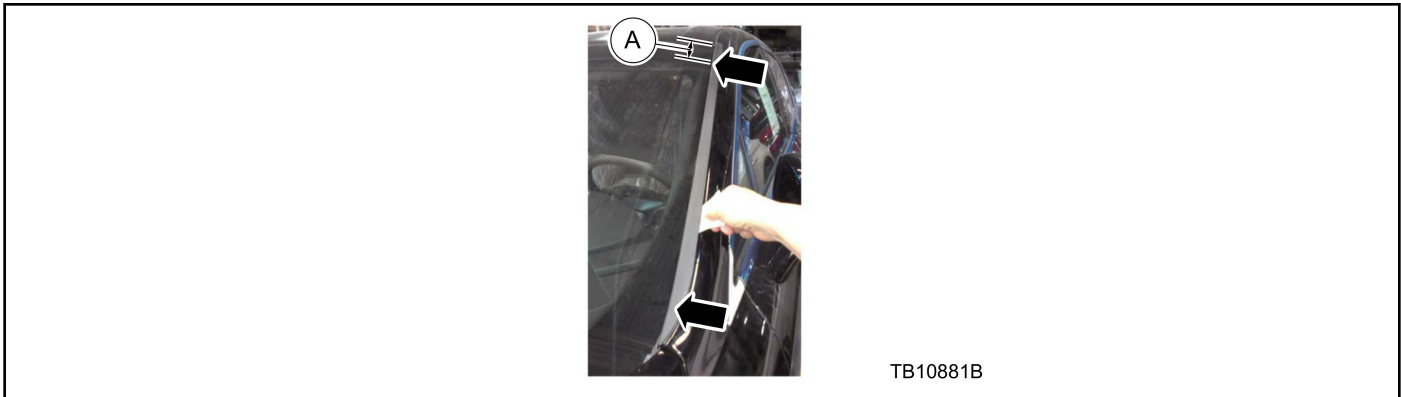
Figure 1 - Article 16-0088

1. Apply masking tape to cover the edge of the windshield and A-pillar moulding. Road test the vehicle. Does the vehicle exhibit wind noise from the windshield A-pillar?
 - a. Yes - this article does not apply. Refer to Workshop Manual (WSM), Section 100-04 for normal diagnostics.
 - b. No - proceed to Step 2.
2. On the back of a regular business card, measure 10 mm (13/32") from the short edge and draw a line.
3. On the passenger and driver side of the vehicle, measure approximately 25 mm (1") dimension A, and insert the business card between the windshield moulding and the metal A-pillar at the three points. At any point, can the business card be inserted more than 10 mm (13/32")? (Figure 1)

- a. Yes - proceed to Step 4.
 - b. No - proceed to Step 5.
4. Replace the windshield. Refer to WSM, Section 501-11.
5. Test fit the right stuffer on the passenger side of the vehicle.
