**LINCOLN:**

2017 Continental

**ISSUE**

Some 2017 Continental vehicles may exhibit a floor console cup holder door that does not operate.

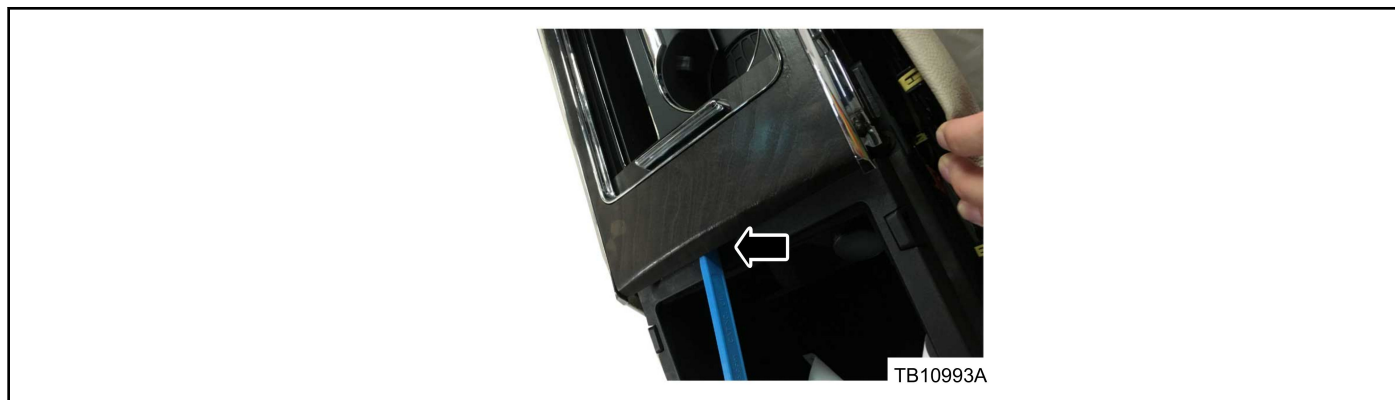
Figure 2 - Article 16-0160

3. Release the retaining clips for the rear of the floor console upper section, using a plastic trim tool and move the rear of the console upper section up.
4. Inspect the louver right and left side tracks for the louver out of the track. (Figure 2)
