**FORD:**

2017 Transit

**ISSUE**

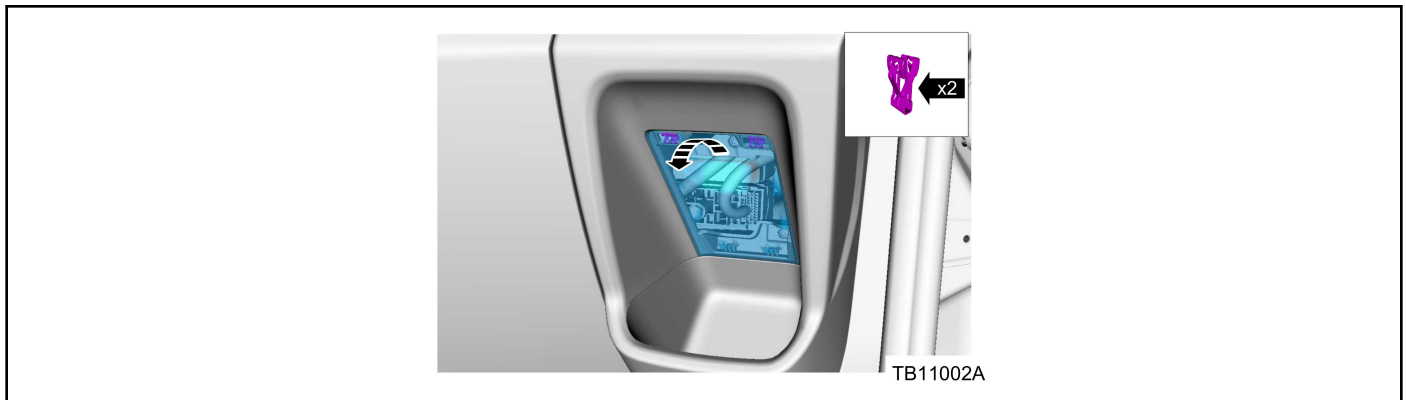
Figure 1 - Article 17-0006

Some 2017 Transit vehicles equipped with an auxiliary junction box and built on or before 17-Oct-2016 may exhibit an inoperative auxiliary relay 8 and/or an inoperative upfit switch 3. This may be due to a missing relay ground circuit.

1. Disconnect the battery ground cable(s). Refer to Workshop Manual, Section 414-01.
2. Release the clips and remove the right side mounted cupholder.
3. Open the glove box and press the stop tabs downward and fully lower the glove compartment door.
4. Release the 2 clips and remove the right side access panel. This allows access to right side instrument panel finish panel screws. (Figure 1)

- a. Tighten screws to 2 Nm (18 lb-in)
16. Install the right side access panel. (Figure 1)
17. Press the glove box stop tabs and close the glove compartment.
