FORD:

2013-2016 C-MAX

TSB 17-0015 (Continued)

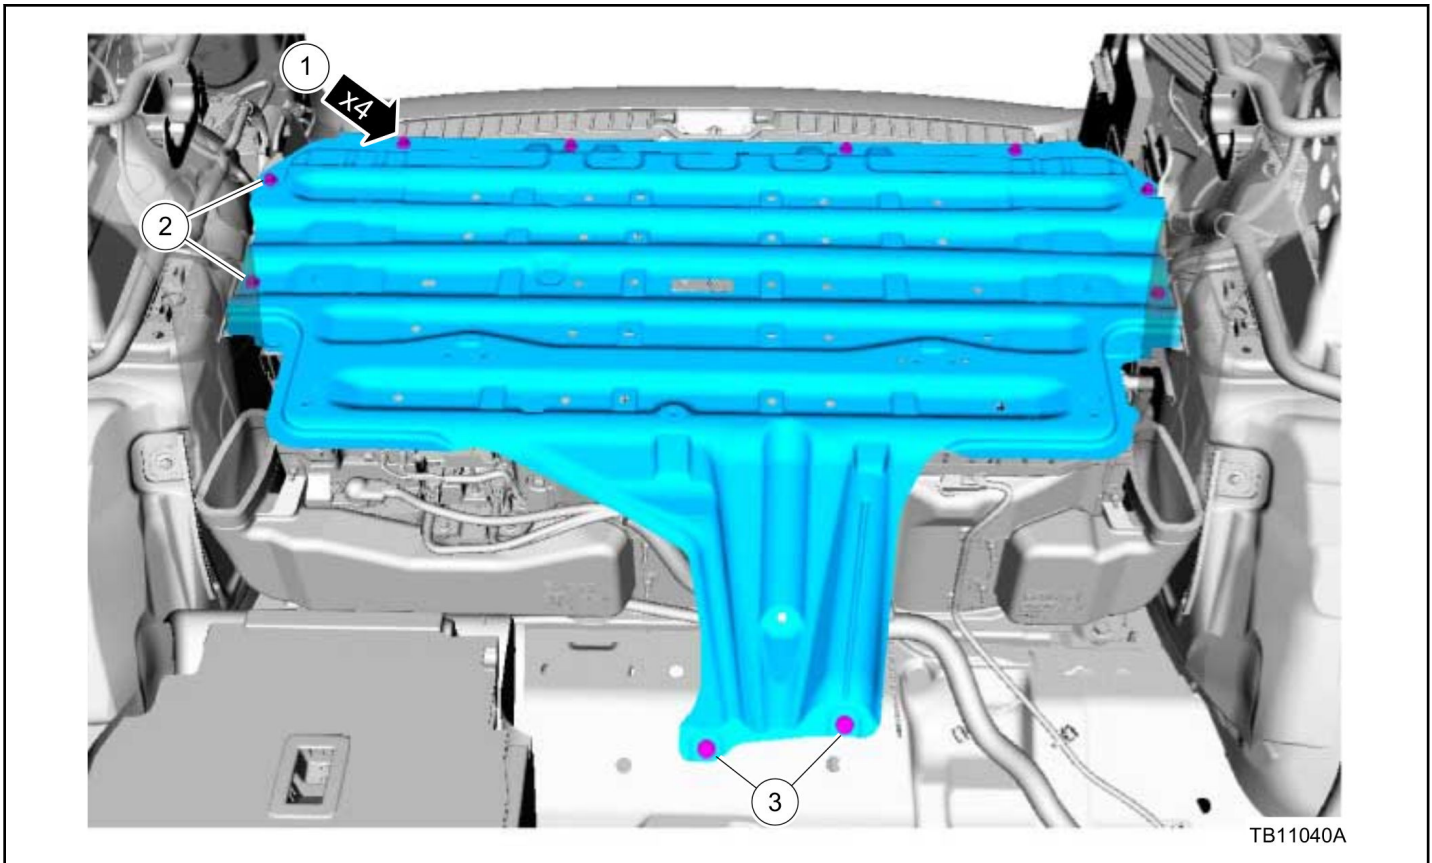
Figure 1 - Article 17-0015

Some 2013-2016 C-MAX Energi vehicles may exhibit an intermittent stall/no crank with a Stop Safely Now warning message in the instrument panel cluster (IPC), illuminated malfunction indicator lamp (MIL) with battery energy control module (BECM) diagnostic trouble codes (DTCs) U3012, P0B37 and/or secondary on-board diagnostic module-C (SOBDM-C) P0A0A.

- a. Tighten the four 8 mm x 45 mm bolts, torque to 30 Nm (22 lb-ft). (Figure 1 Item 1)
 - b. Tighten the four 8 mm x 25 mm bolts, torque to 30 Nm (22 lb-ft). (Figure 1 Item 2)
 - c. Tighten the two 10 mm x 20 mm bolts, torque 62 Nm (46 lb-ft). (Figure 1 Item 3)
6. Inspect the low voltage interlock circuits, CYB03 and CYB04 for a chafed wire near C4002 between the traction battery cover plate and the traction battery. Is chafing present?
 - a. Yes - chafing was found between the traction battery cover plate and the traction battery, proceed to Step 7.
 - b. No - chafing was not found, proceed to Step 8.
 7. Remove the affected circuit from the connector, apply heat shrink tubing over the chafed area of the circuit and apply Coroplast tape over the heat shrink tube. Secure the 10B689 harness to prevent repeat occurrence. (Figure 2)
