**FORD:**

2011-2015 Explorer

This article supersedes TSB **14-16-NA** and **14-04-NA** to update the Service Procedure.

## TSB 17-0029 (Continued)

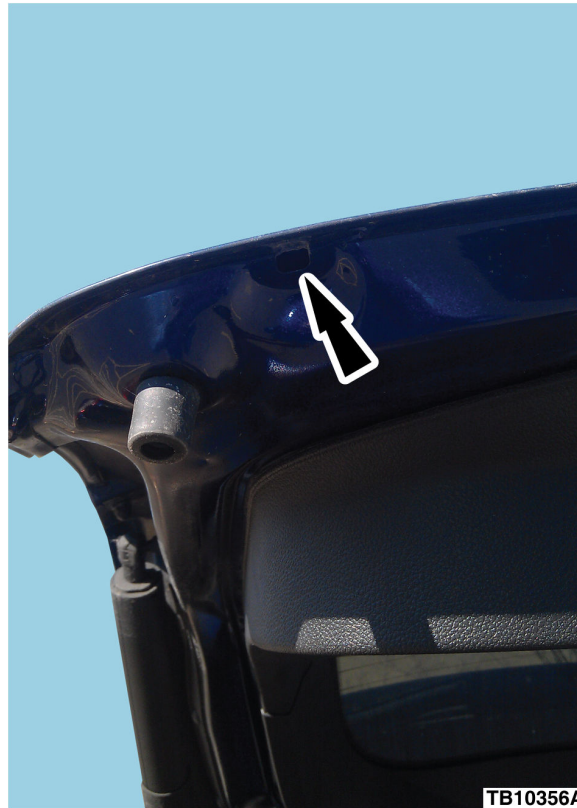
Figure 1 - Article 17-0029

1. Remove the rear bumper cover. Refer to Workshop Manual (WSM), Section 501-19.
2. Remove the left and right tail lamps. Refer to WSM, Section 417-01.
3. Remove the wheel lip mouldings. Refer to WSM, Section 501-08.
4. Open the liftgate and inspect for presence of drain valves in the two (2) drain holes on the left and right side of the liftgate. Are the drain valves present? (Figure 1)

- a. Yes - proceed to Step 6.
  - b. No - proceed to Step 5.
5. Install a new drain valve in each of the two (2) drain holes on the left and right side of the liftgate. (Figure 1)
  6. Inspect the liftgate seal for damage and proper fit/contact pattern. Adjusting the rear liftgate striker so that the rear hatch seals tighter to the liftgate seal is important. This can be done by loosening the striker and moving it to increase the liftgate sealing pressure.
  7. Inspect the left and right side air extractors for proper fit to the body and operation/sealing of the rubber flaps.
    - a. Replace the air extractor if it is warped or damaged or flaps do not lay flush to their sealing surface. (Figure 2)

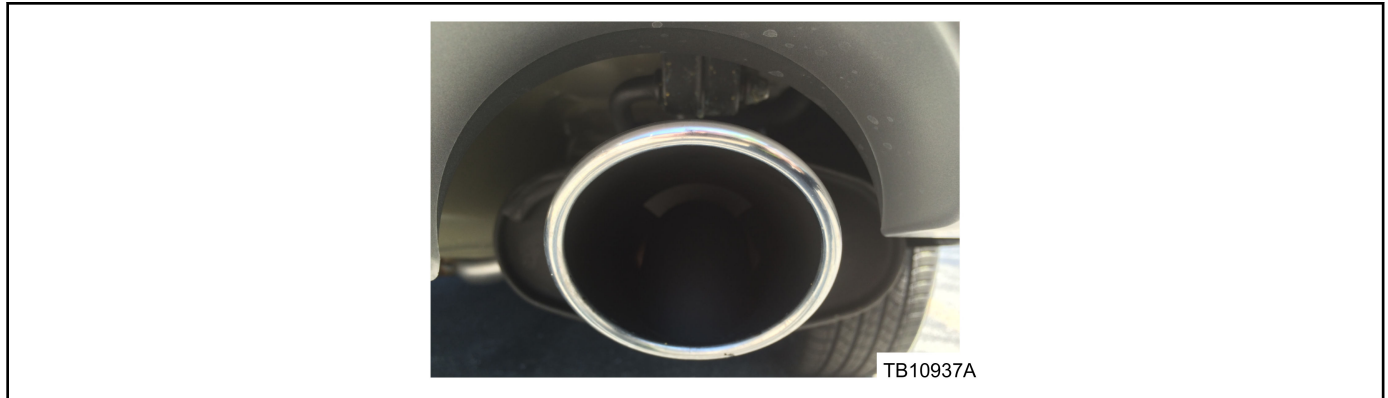
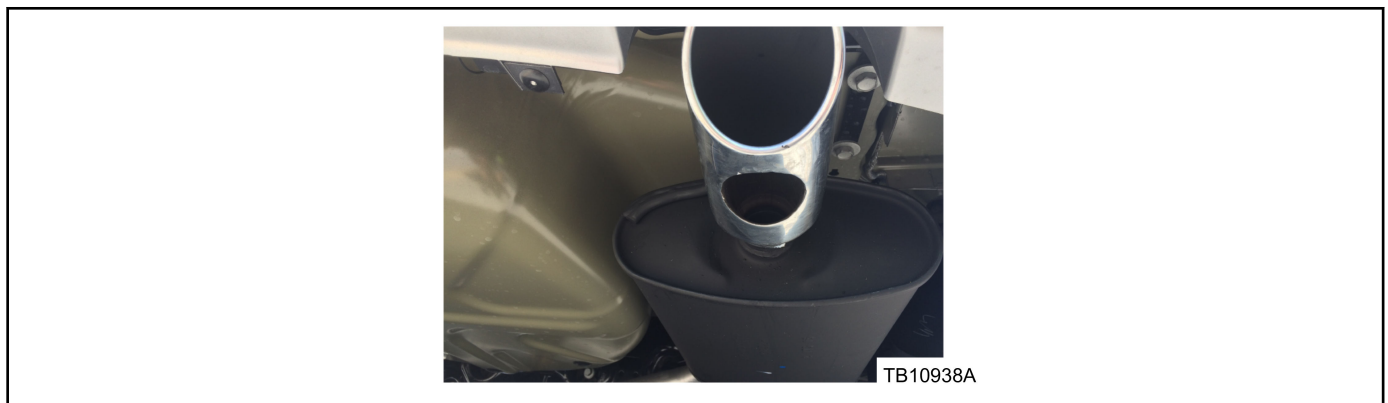
18. Inspect the exhaust tips. Are down turned exhaust tips present? (Figure 8)
  - a. Yes - proceed to Step 19.
  - b. No - remove the rear section of the exhaust system and proceed to Step 20. Refer to WSM, Section 309-00.

- a. Yes - inform the customer of the redesigned exhaust tips and that appearance will remain the same but the exhaust will exit the tip from bottom. Upon acceptance, replace the muffler assembly with the updated part containing the down turned exhaust tips. Refer to WSM, Section 309-00. (Figures 7-8)
