**CREAK NOISE DURING BODY FLEX AND/OR TWIST - LEFT SIDE B PILLAR AND/OR LEFT SIDE ROCKER PANEL - BUILT ON 17-JAN-2017 AND THROUGH 15-MAY-2017**

**TSB 17-0059**

2017 Escape

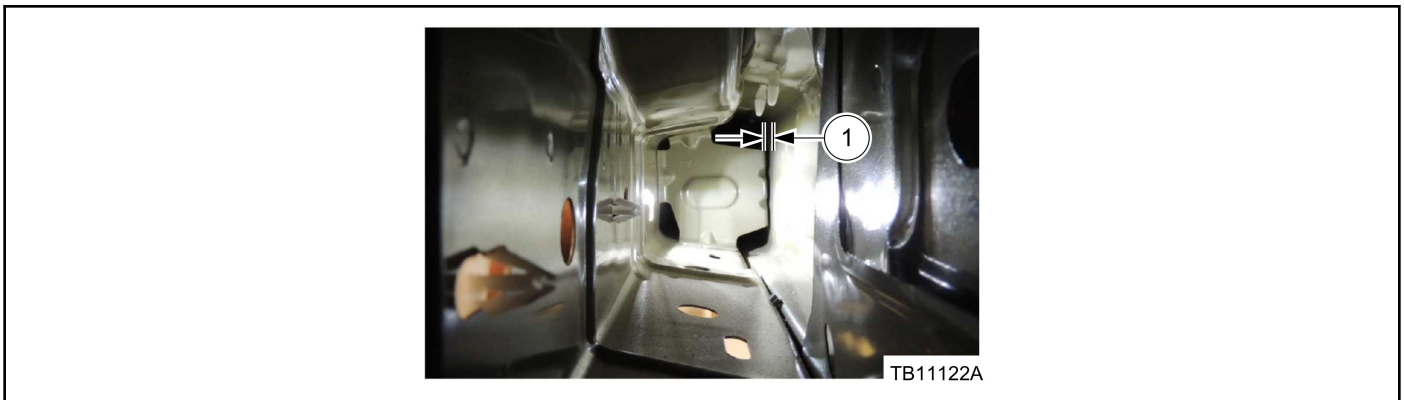
Figure 1 - Article 17-0059

Some 2017 Escape vehicles built on 17-Jan-2017 and through 15-May-2017 may exhibit a creak noise during body flex and/or twist coming from the left side lower B-pillar and/or rocker panel. This may be due to a lack of rocker panel bracket to inner rocker panel clearance.

1. Drive the vehicle over uneven, rough roads and/or twist body structure by performing turns. Does the vehicle exhibit a creak noise from the left side rocker panel and/or lower B-pillar area?
  - a. Yes - proceed to Step 2.
  - b. No - this article does not apply. Refer to Workshop Manual (WSM), Section 100-04 for normal diagnostics.
2. Remove the left rear wheel and tire. Refer to WSM, Section 204-04.
3. Remove one plastic push pin from the left rear fender splash shield and position the fender splash shield aside. Remove the rubber body plug installed in the end of the rocker panel.
4. Using a prybar or equivalent tool of approximately 61 cm (24") long, create a 2-4 mm (0.079-0.157 inches) clearance between the rocker panel bracket and the rocker inner panel. (Figure 1)

5. Apply ValuGard™ Rust Inhibitor VG104, VG104A or equivalent to the inner surfaces of the rocker panel where interior corrosion coating damage may have occurred during the prying process. Refer to WSM, Section 501-25.
6. To install, reverse the removal procedure. Refer to WSM, Section 204-04.
