FORD:

2013-2015 Explorer, Flex, Taurus

LINCOLN:

2013-2015 MKS, MKT

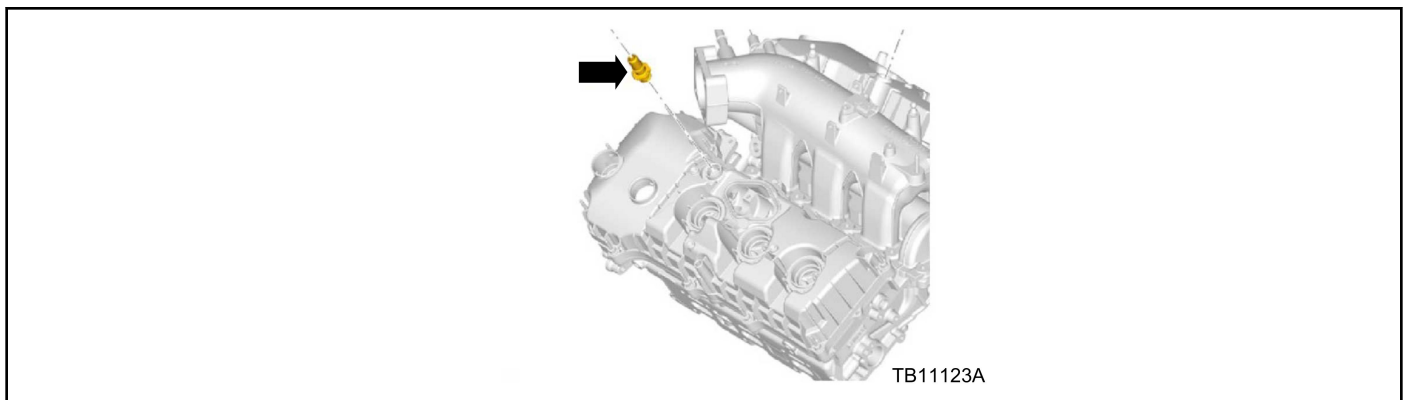
Figure 1 - Article 17-0063

Some 2013-2015 Explorer/Police Utility/Taurus/Police Sedan/MKS/Flex/MKT vehicles equipped with a 3.5L Gasoline Turbocharged Direct Injection (GTDI) engine may exhibit blue or white smoke from the exhaust while driving after extended idle.

1. Remove the engine appearance cover, if equipped. Refer to Workshop Manual (WSM) Section, 303-08.
2. Inspect the color of the positive crankcase ventilation (PCV) hose to valve cover adapter. Is the adapter black in color? (Figure 1)

- a. Yes - proceed to Step 3.
 - b. No - this article does not apply. Refer to the Powertrain Control/Emissions Diagnosis (PC/ED) manual for diagnosis.
3. Disconnect the PCV hose to valve cover adapter quick connect fitting from the valve cover adapter. Refer to WSM Section 310-00.
 - a. When the valve cover adapter is removed, damage will occur to the valve cover adapter locking mechanism. Make sure detached pieces of the valve cover locking mechanism do not fall into the open valve cover port during removal. Rotate the adapter counterclockwise and remove from valve cover.
 4. Lubricate the new valve cover adapter O-ring seal with clean engine oil.
 5. Install the new green valve cover adapter.
 6. Connect the PCV hose to the valve cover adapter.
 7. Install the engine appearance cover if equipped. Refer to WSM, 303-08.
