NUMBER: 18-013-05 REV. A

GROUP: Vehicle Performance

DATE: April 19, 2005

Flash: Idle Fluctuation/Diagnostic Trouble Codes

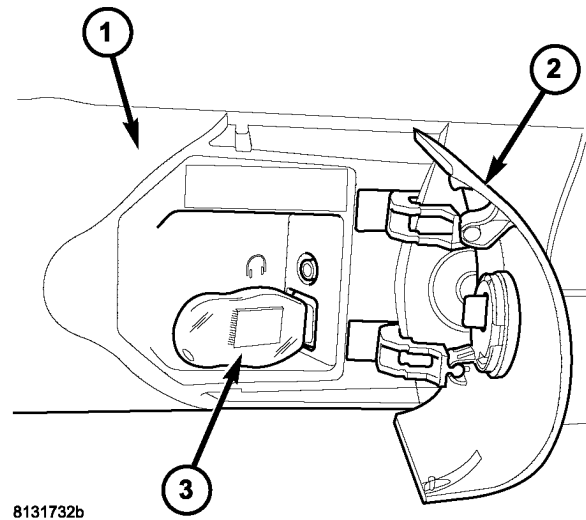
Fig. 2 USB KEY AND TECHCONNECT PC

1. Retrieve the old PCM part number. Using the StarSCAN at the "Home" screen:
 - a. Select "ECU View"
 - b. Touch the screen to highlight the PCM in the list of modules.
 - c. Record the "Part Number", displayed on the "ECU Overview" screen, for later reference.
2. Insert the USB Key, into the USB port on the TechCONNECT or equivalent PC (Fig. 2).

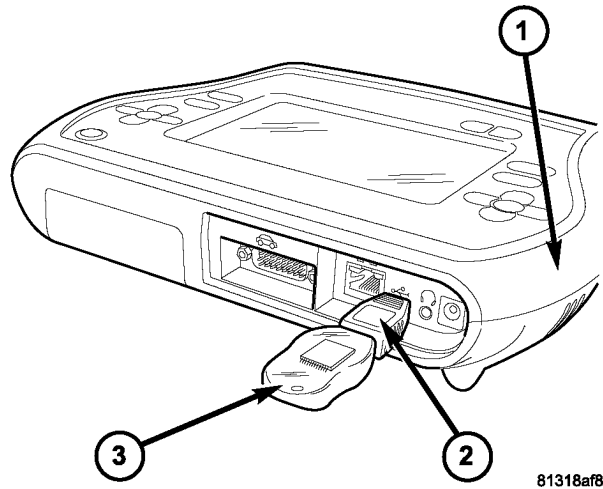
Fig. 3 USB KEY, GENDER CHANGER, AND StarSCAN TOOL

8. With the StarSCAN powered OFF, connect the USB Key and Gender Changer to the StarSCAN USB port ([Fig. 3](#)).
