NUMBER: 18-053-15 REV. A

Malfunction Indicator Lamp (MIL) Illumination P0344 - Camshaft Position Sensor Intermittent

2012 - 2015 (JK)

Jeep Wrangler (RHD)

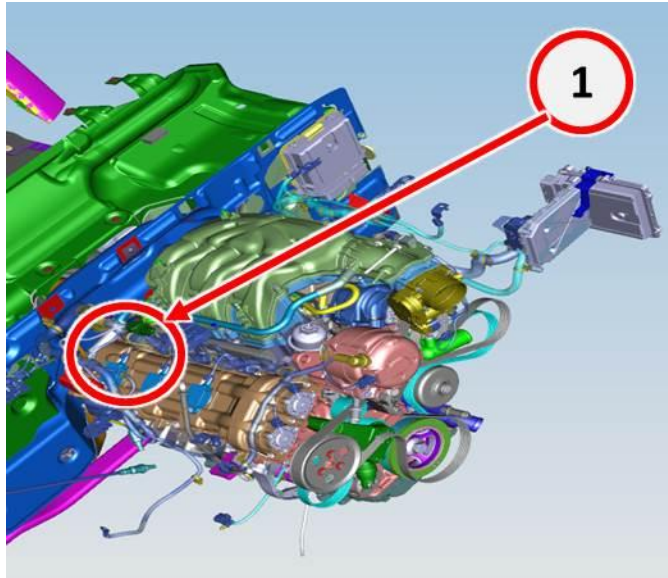
Fig. 1 Underhood Engine View

1 - Engine harness repair location

1. Remove the engine cover.
2. Locate the engine wire harness tower clip on the right side of the engine near the camshaft position sensor. See (Fig. 1).

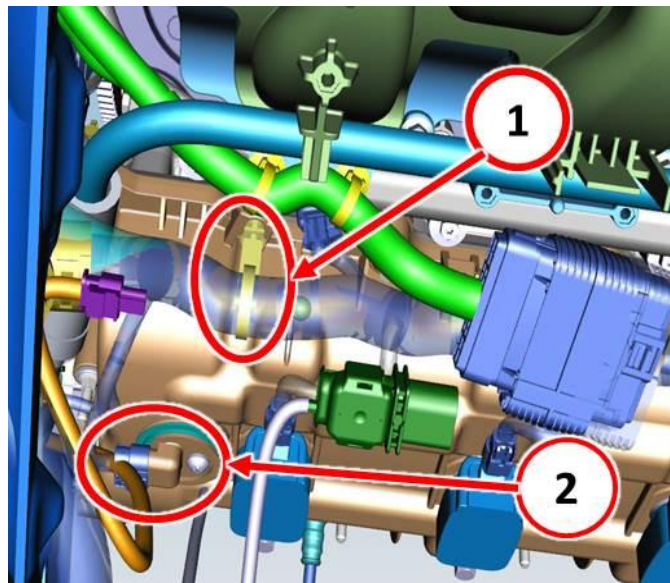
Fig. 2 Engine Wire Harness

- 1 - Engine harness tower clip
- 2 - Camshaft Position Sensor (CMP)

-
3. Remove the existing wire harness tower clip and install P/N 68289129AA tower clip in the same location on the wire harness. See (Fig. 2). Engage the tower clip to the cylinder head cover. The new tower clip should be a tighter fit to the cylinder head cover than the removed clip.

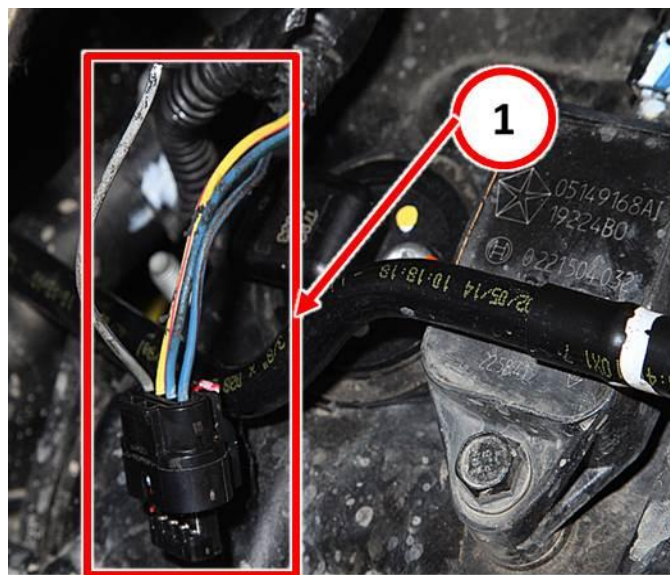
Fig. 3 CMP Sensor Connector

- 1 - CMP wire harness damage
-

-
4. Repair any damaged wiring to the CMP harness near the connector. See (Fig. 3). Refer to detailed repair instructions in DealerConnect/TechConnect Service Information Section 29 - Non-DTC Diagnostics> Circuit Testing Procedures> Standard Procedure> WIRE SPLICING.
