TECHNICAL SERVICE BULLETIN

Fuel Filler Door Not Flush With Rear Quarter Panel When Closed - Built On Or Before 8-Dec-2017

18-2038

Ford 2018 Expedition
Lincoln 2018 Navigator

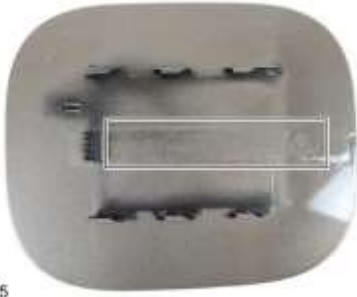
Figure 1

Issue: Some 2018 Expedition/Navigator vehicles built on or before 8-Dec-2017 may exhibit a fuel filler door that is not flush with the rear quarter panel when closed.

1. Was the vehicle built on or before 8-Dec-2017?
 - (1). Yes - proceed to Step 2.
 - (2). No – this article does not apply. Refer to Workshop Manual (WSM), Section 501-03.
2. Remove the fuel filler door. Refer to WSM, Section 501-03.
3. Using a soft cloth, lay the fuel filler door down so the inside surface is facing up.
4. Locate the raised rectangular area on the inside surface of the fuel filler door. (Figure 1)

5. Using a small rotary grinding tool or equivalent, grind away the raised material in this area.
6. Remove material until the raised area is flat to the entire adjacent surface.
7. Reinstall fuel filler door to vehicle. Refer to WSM, Section 501-03.
