TECHNICAL SERVICE BULLETIN

6.7L Diesel - Block Heater Inoperative And/Or Tripping Electrical Breaker/GFCI Outlet - Built On Or Before 24-Oct-2017

18-2116

Ford
2017 F-Super Duty

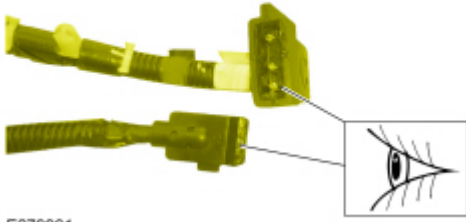
4. Replace the block heater power cable. Inspect the new block heater power cable for electrical grease within the inline connector. Is there electrical grease present? (Figures 2 - 3)

5. Fill the inline connector of the new power cable with Motorcraft® Electrical Grease or equivalent.
6. Install the new block heater power cable; following the routing of the old power cable.
7. To install the right front fender splash shield, reverse the removal procedure.
